**Building Science
Summit
New Zealand**

Façade Risk Mitigation

A look to the future based on lessons from the past

Brian Hubbs | P.Eng.
Founder, Principal, Senior Specialist
brian@rdh.com

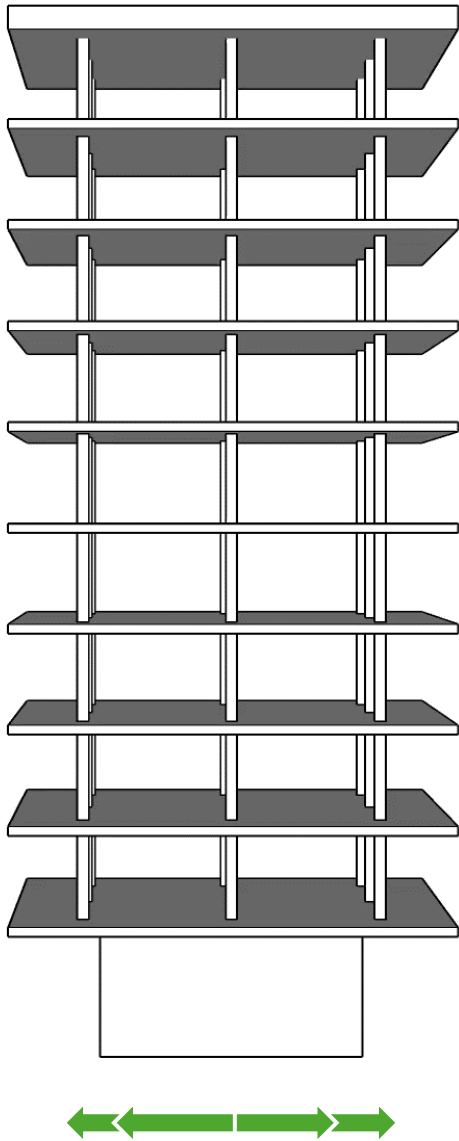
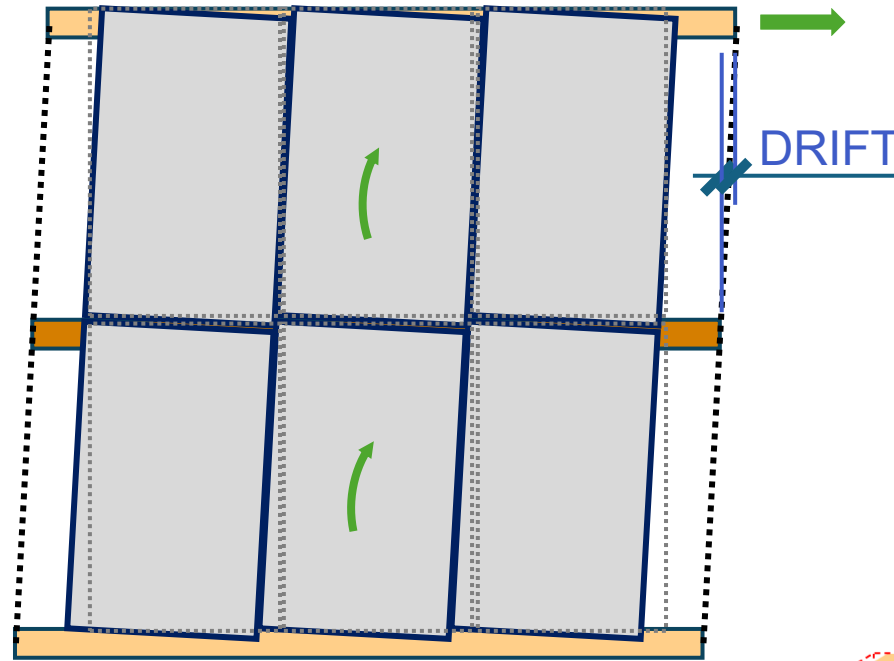
Building Interstory Drift

Typically expressed as %
of story height

1. **Elastic/service** interstory drift **10 mm to 25 mm**
2. **Inelastic** interstory seismic drift (The Big One) **50 mm to 75 mm**

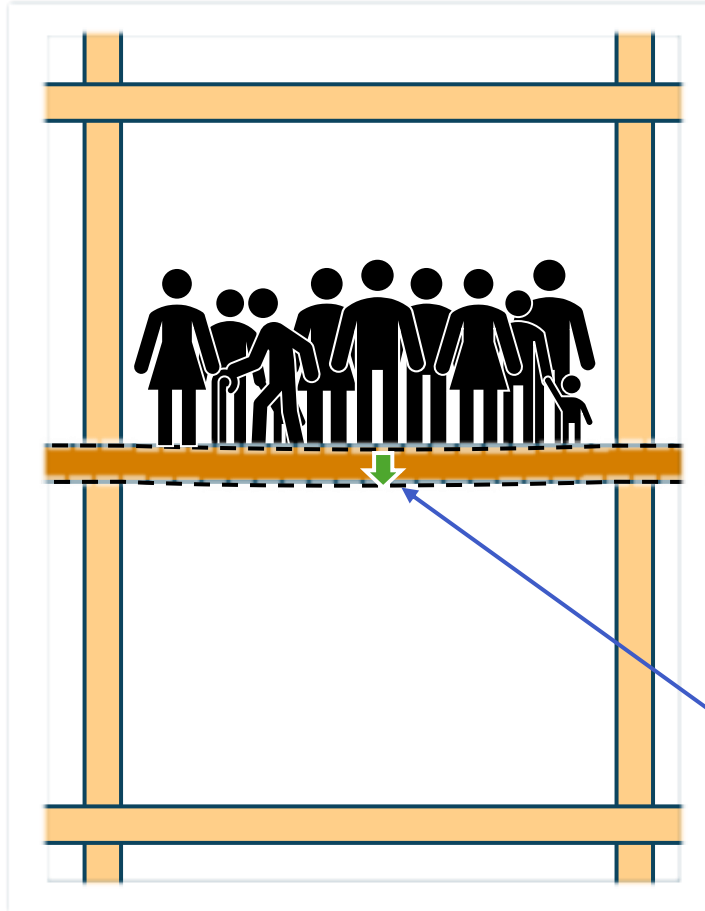
Don't Forget About Differential Vertical Movement

The façade needs to be able to move with its slab, and clearances at each joint.

Typically up to 15-30mm

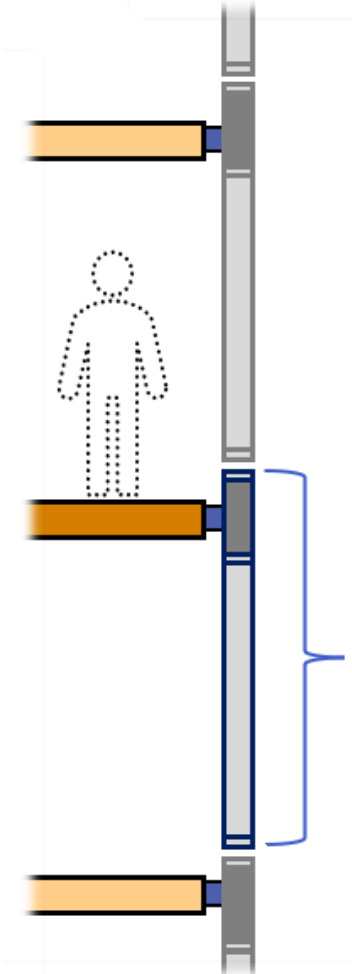
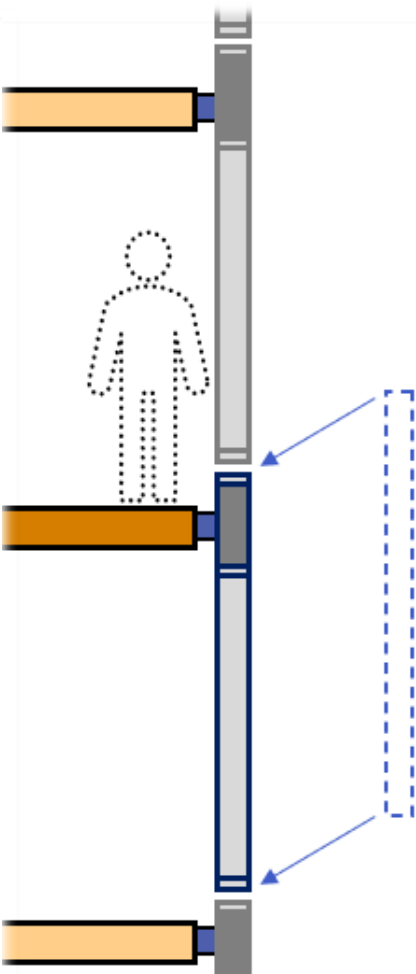
Curtain Wall

Hung From exterior

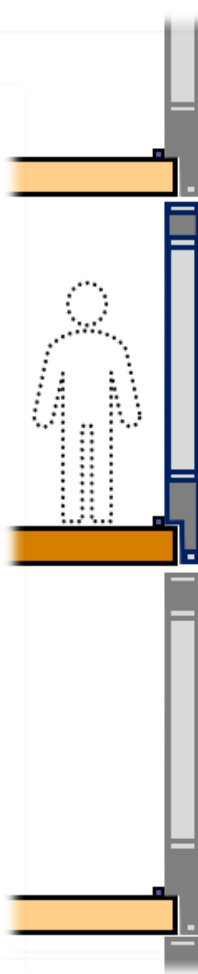
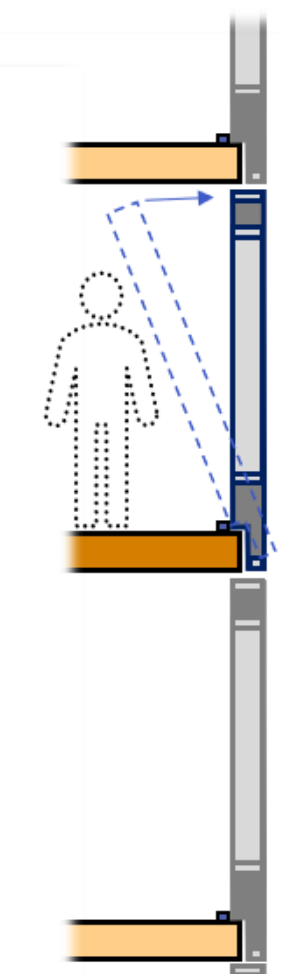
Window Wall

Bottom Bearing Unit

Placed From interior

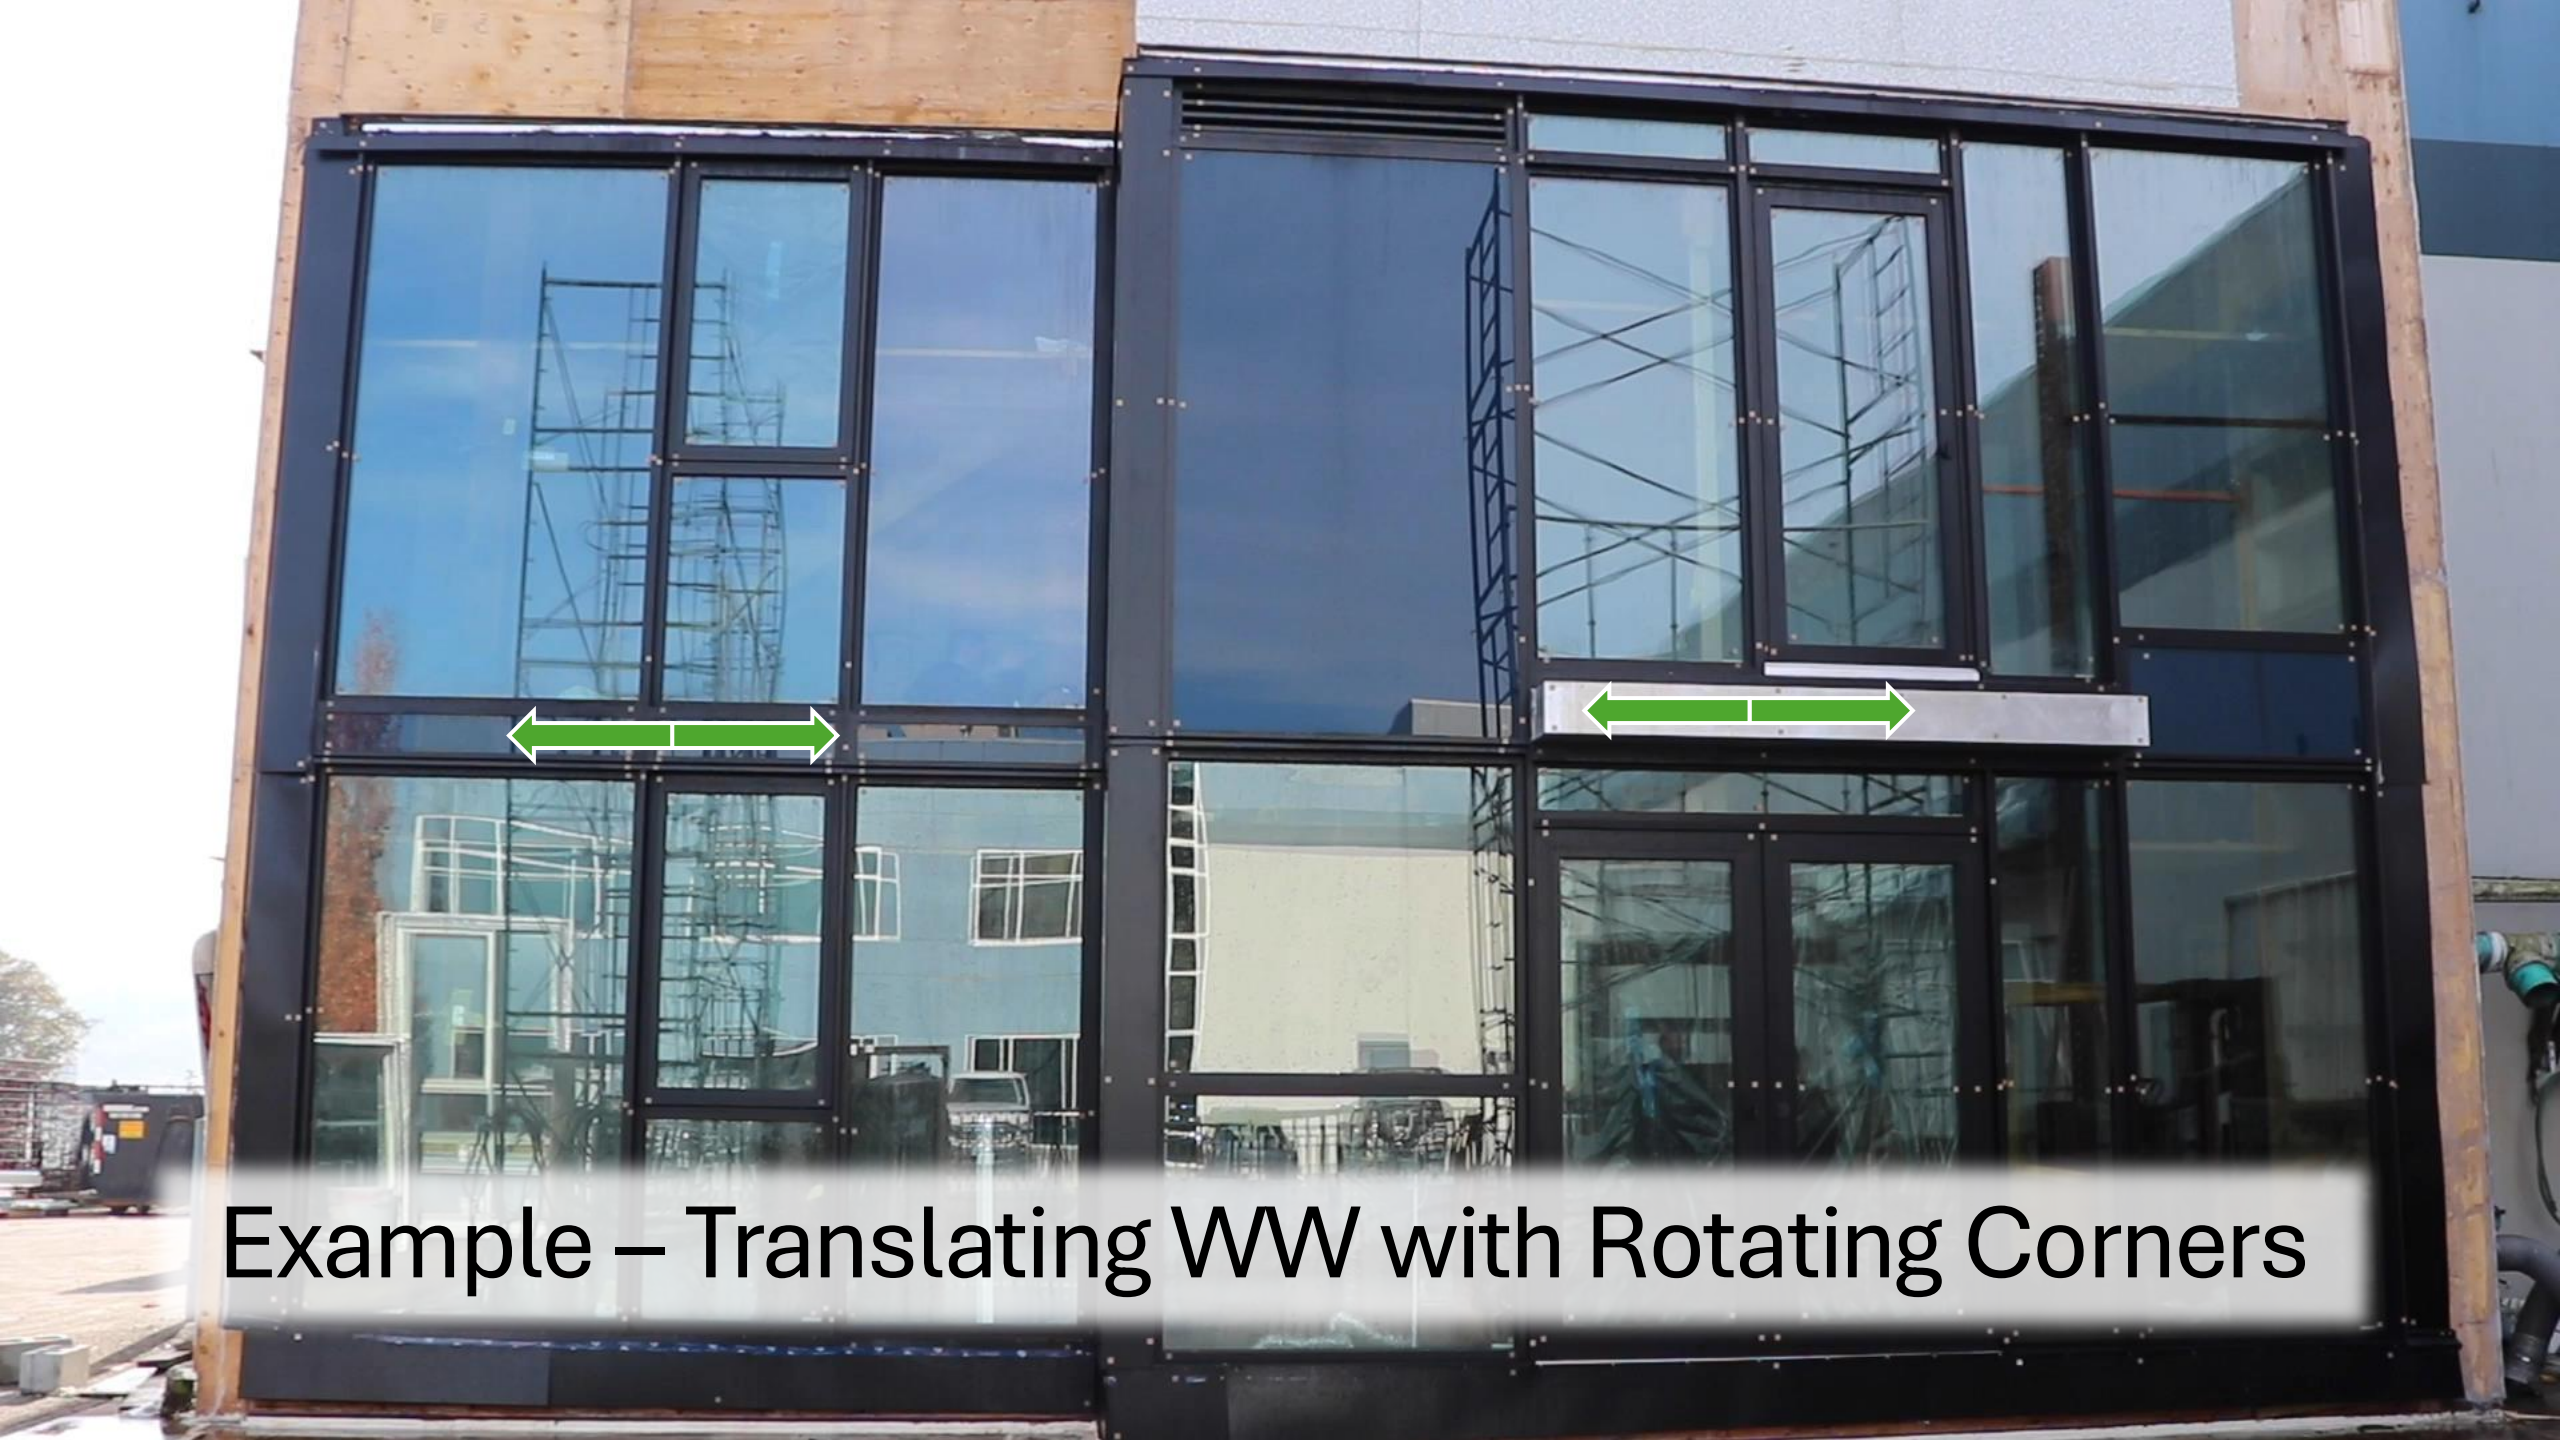
Example – Translating WW with Rotating Corners

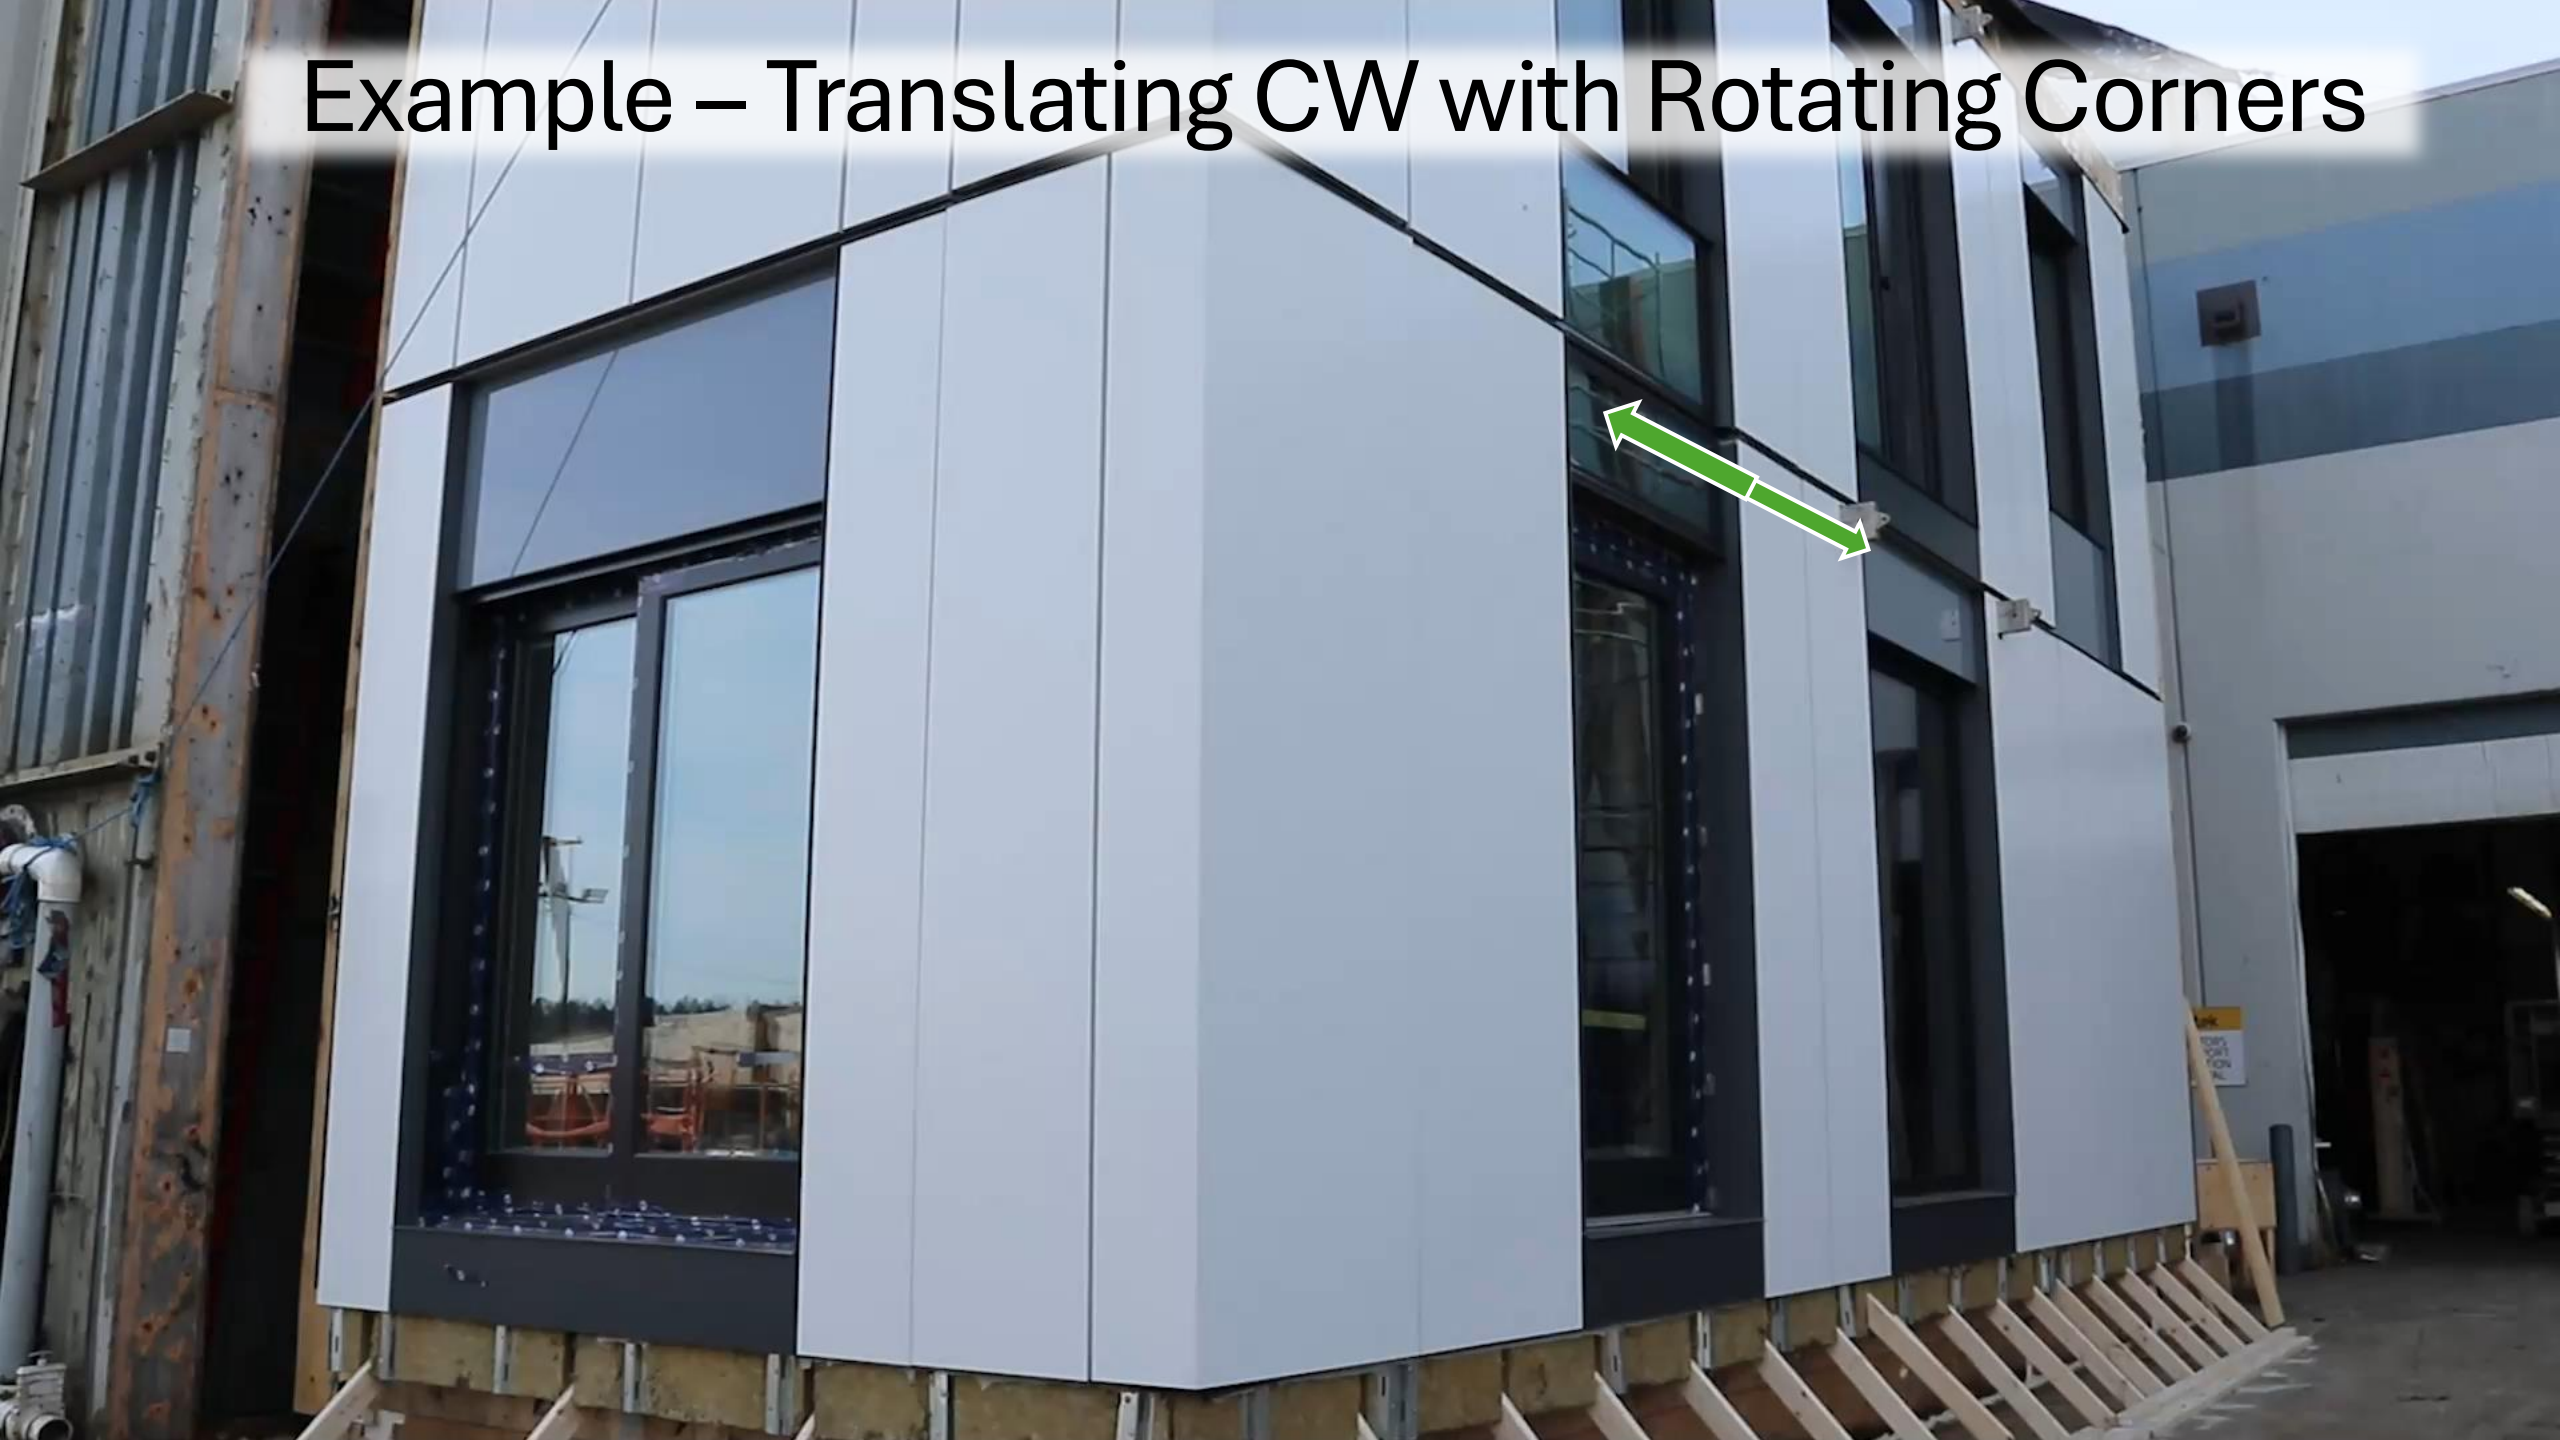
Example – Translating CW with Rotating Corners

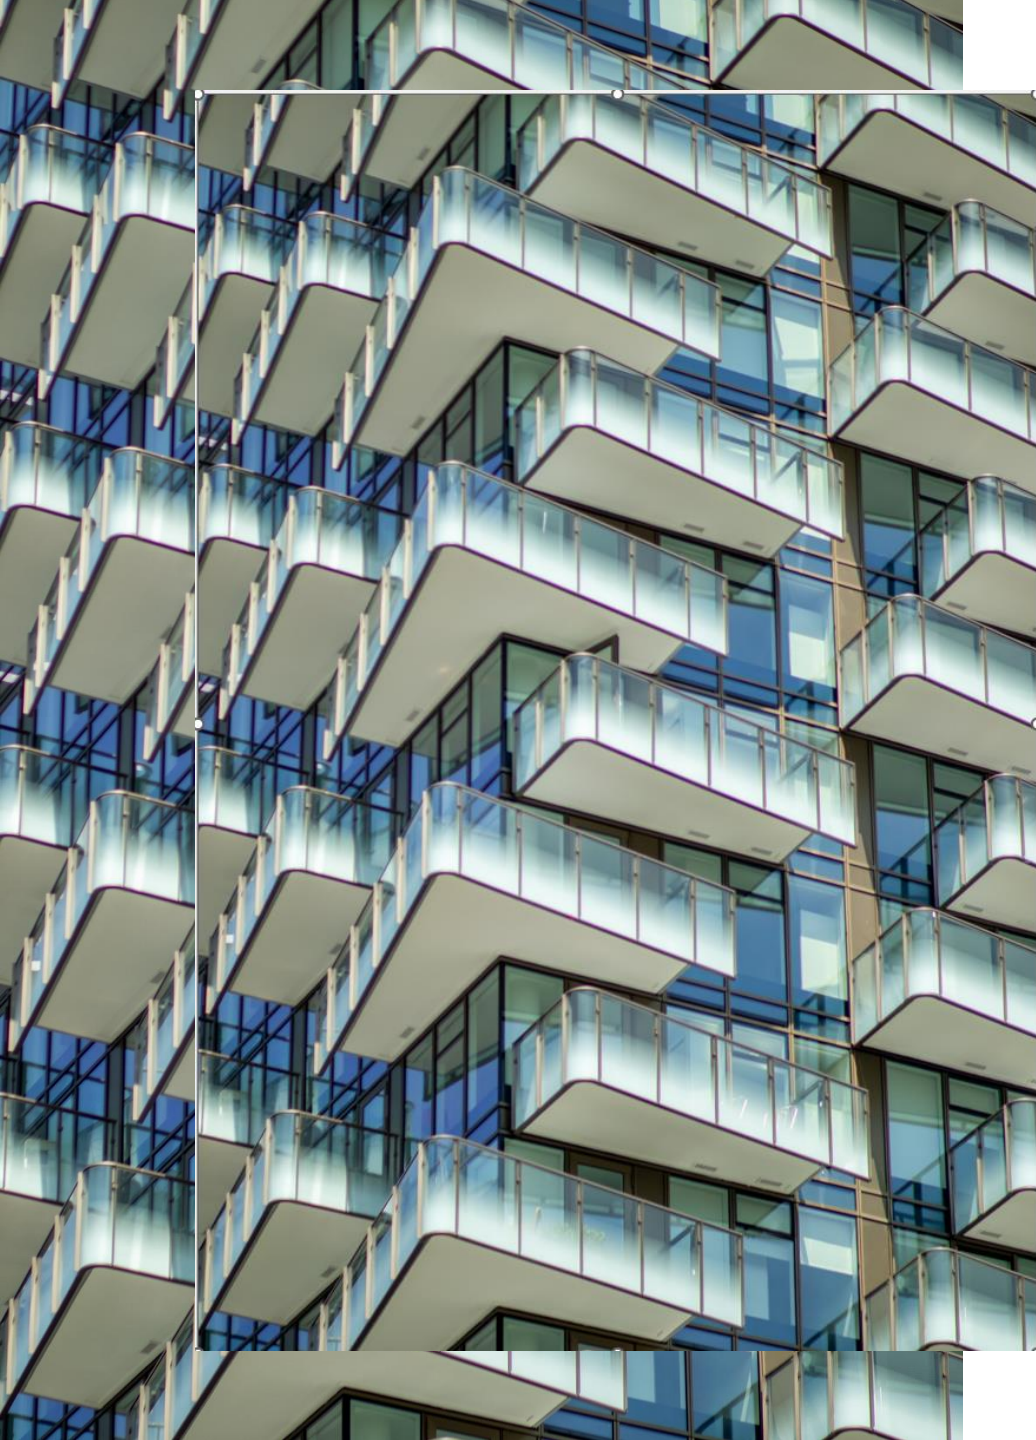
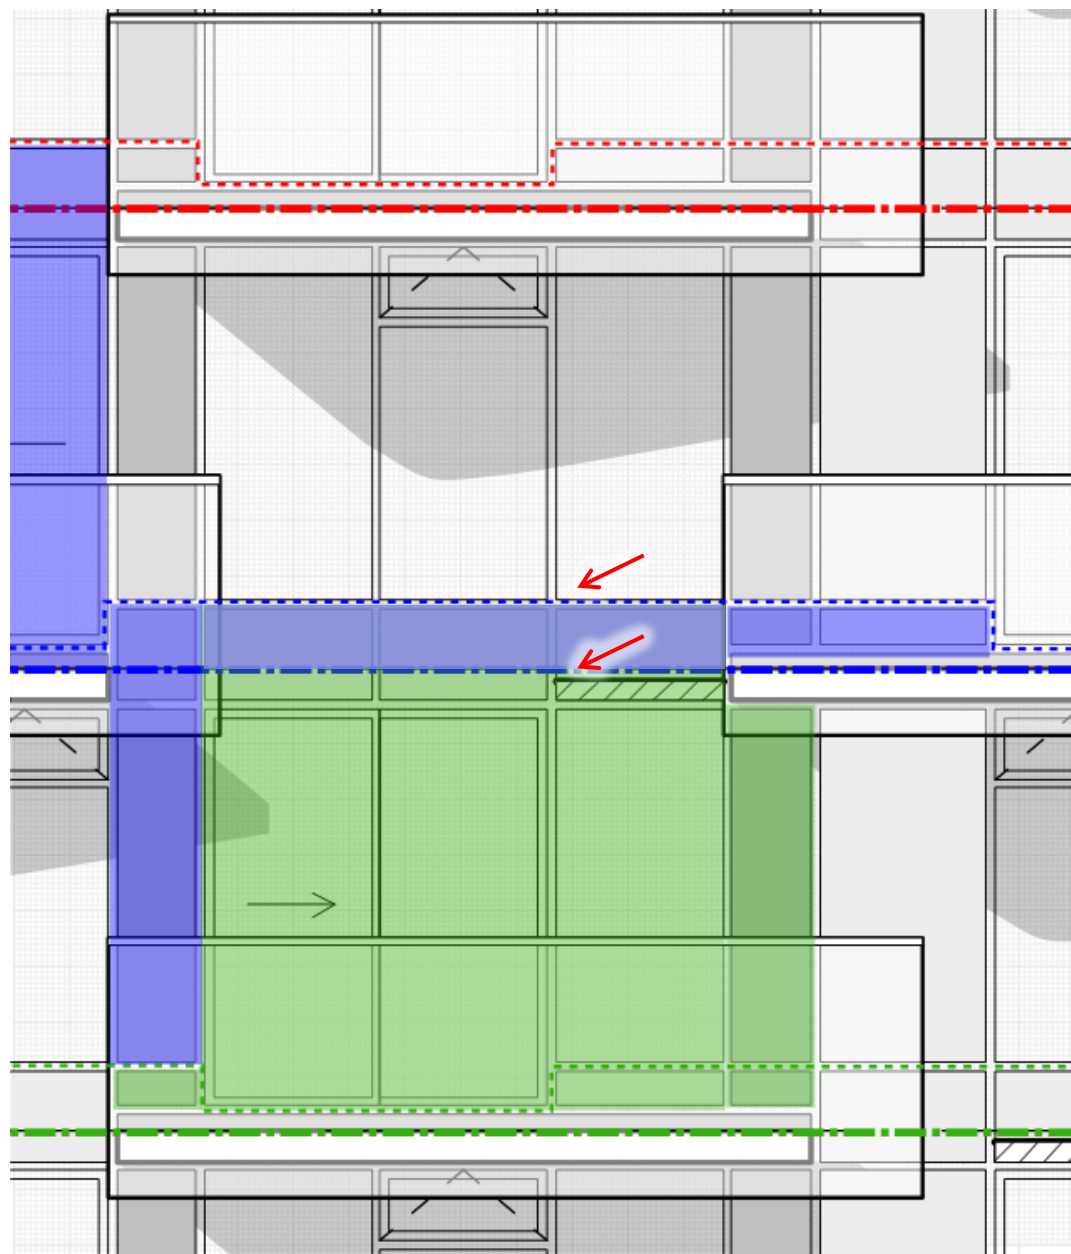
Example - Rotating CW

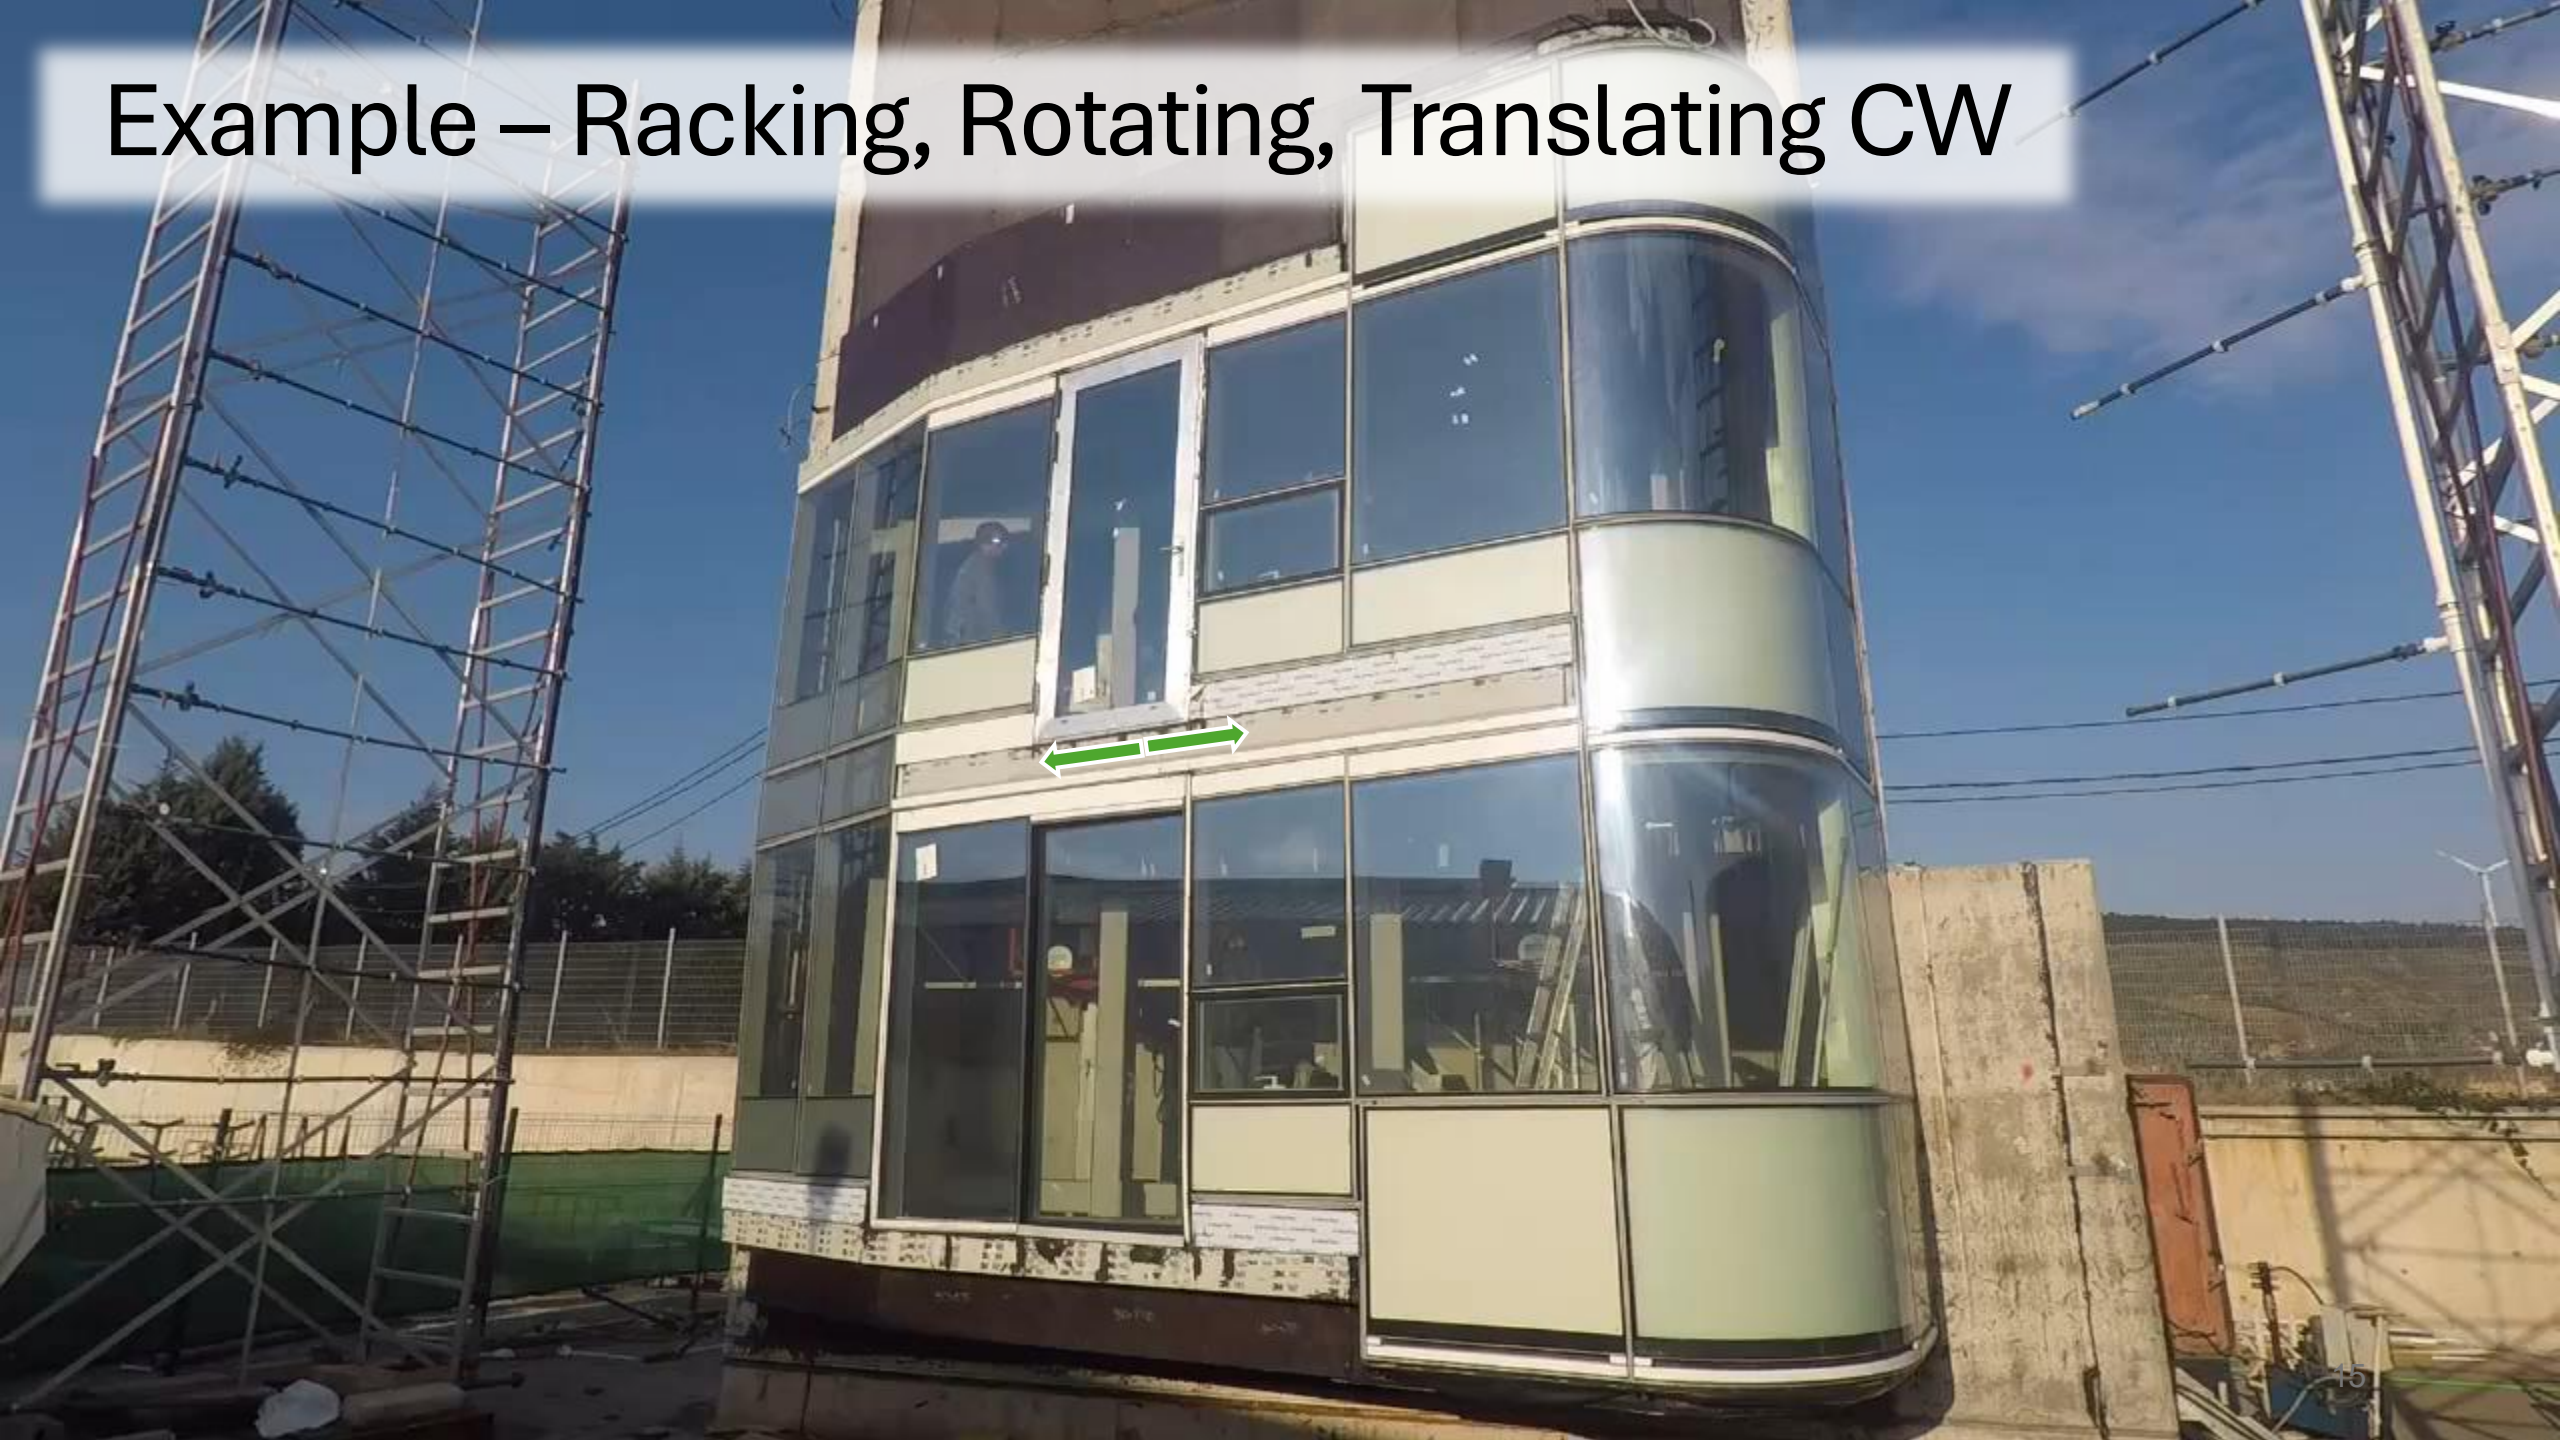
Example – Racking, Rotating, Translating CW

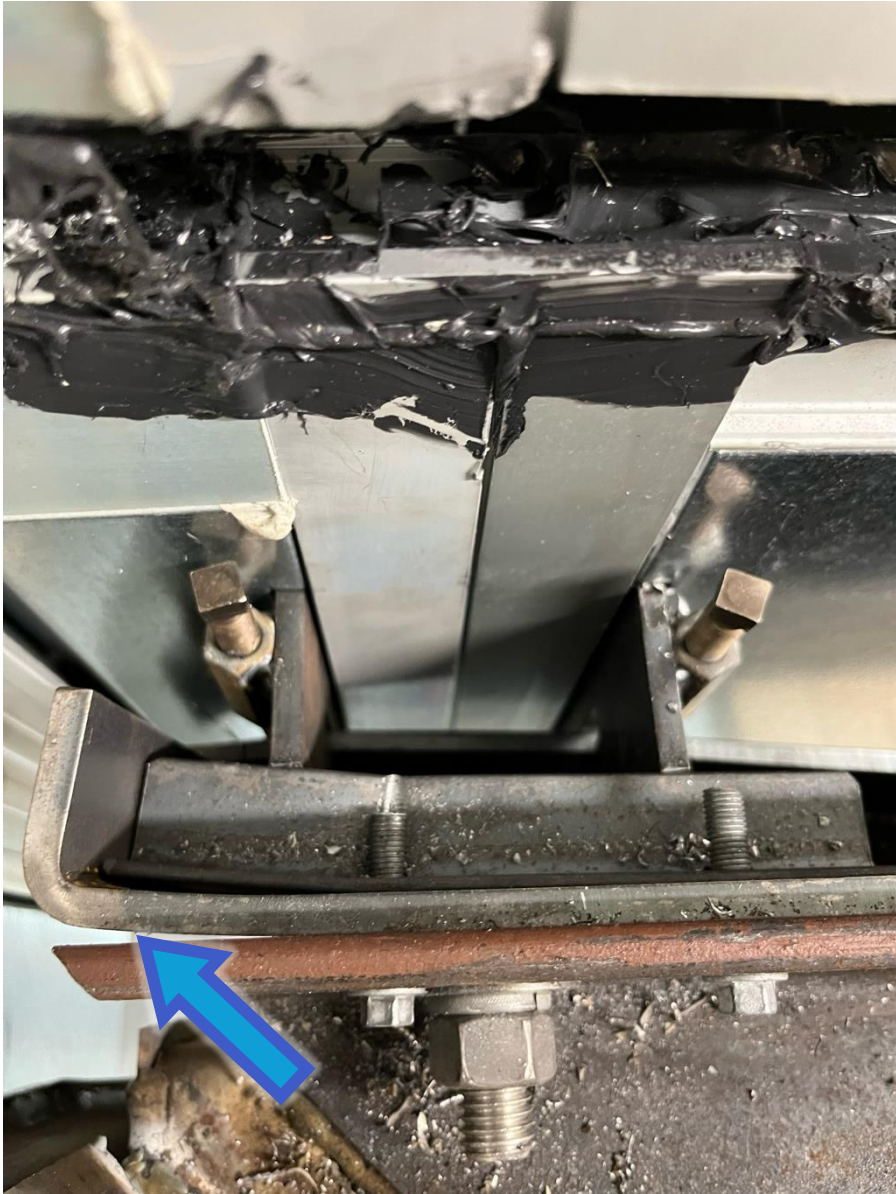
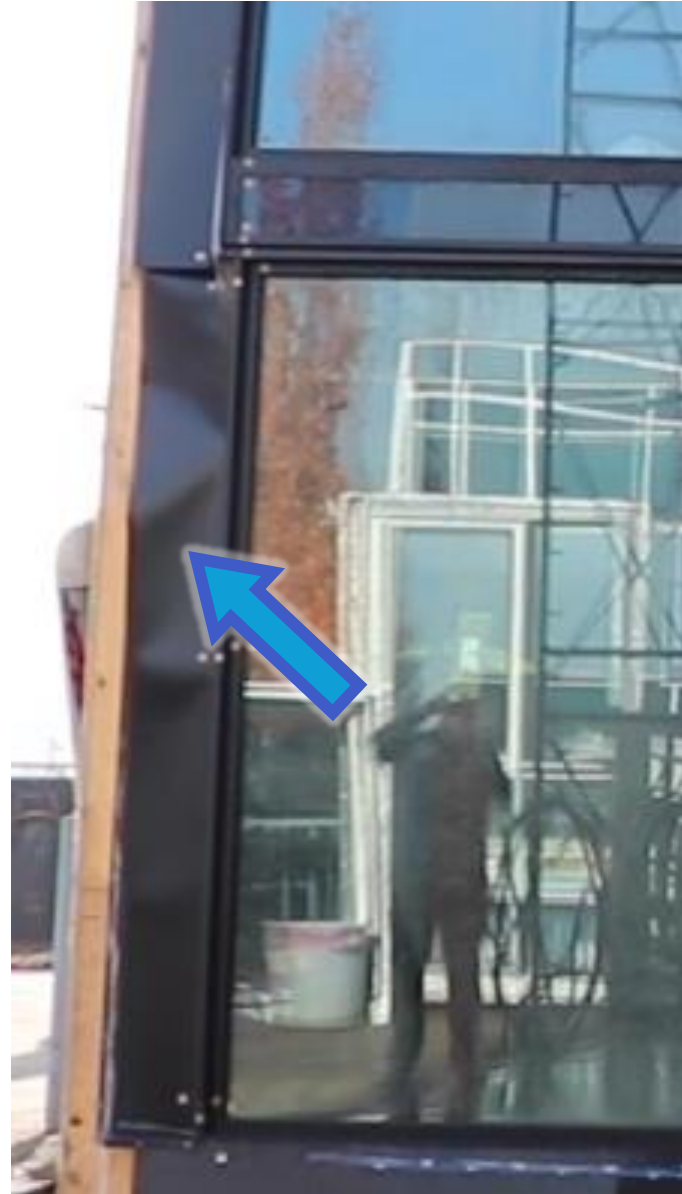
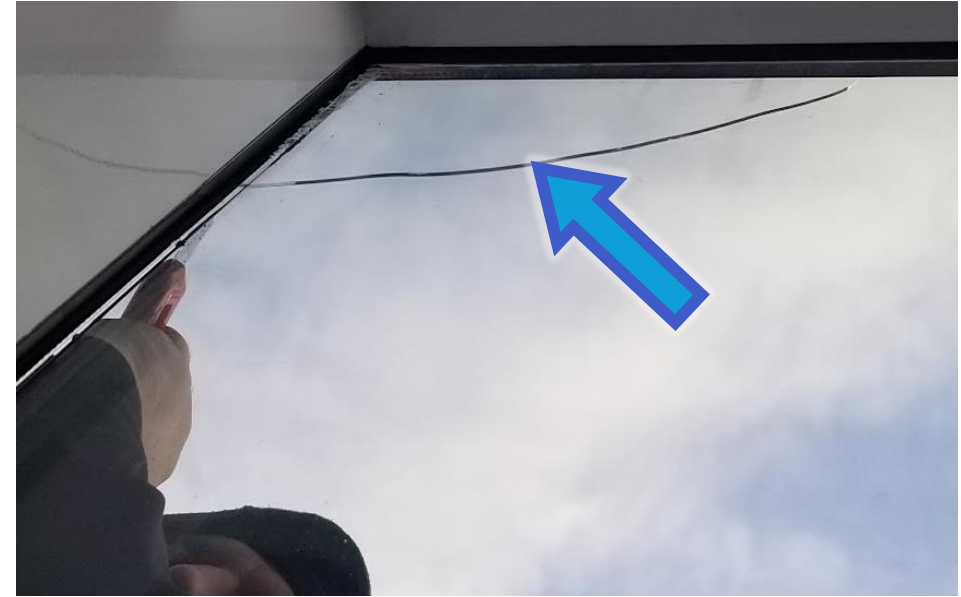
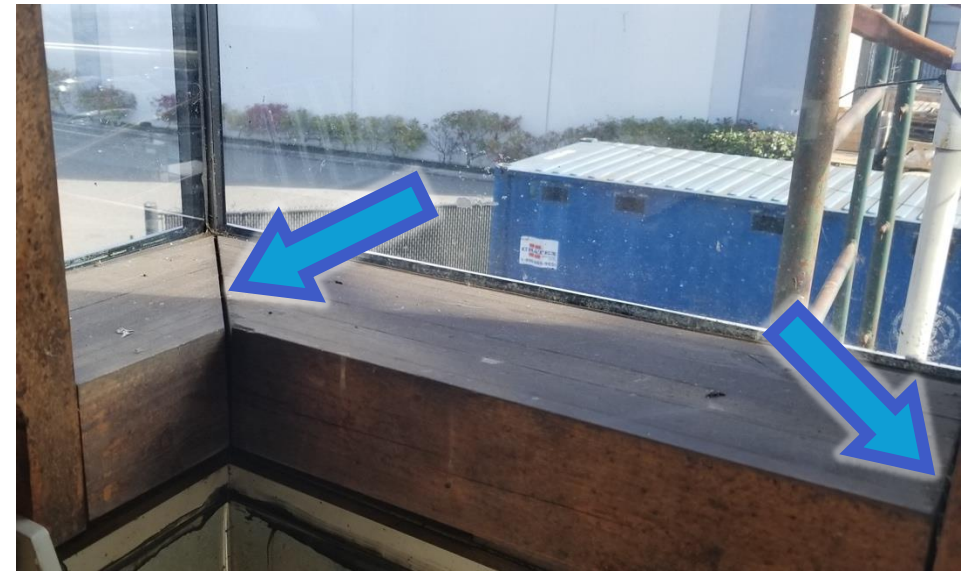
PMU Interstory Drift – Pass or Fail?

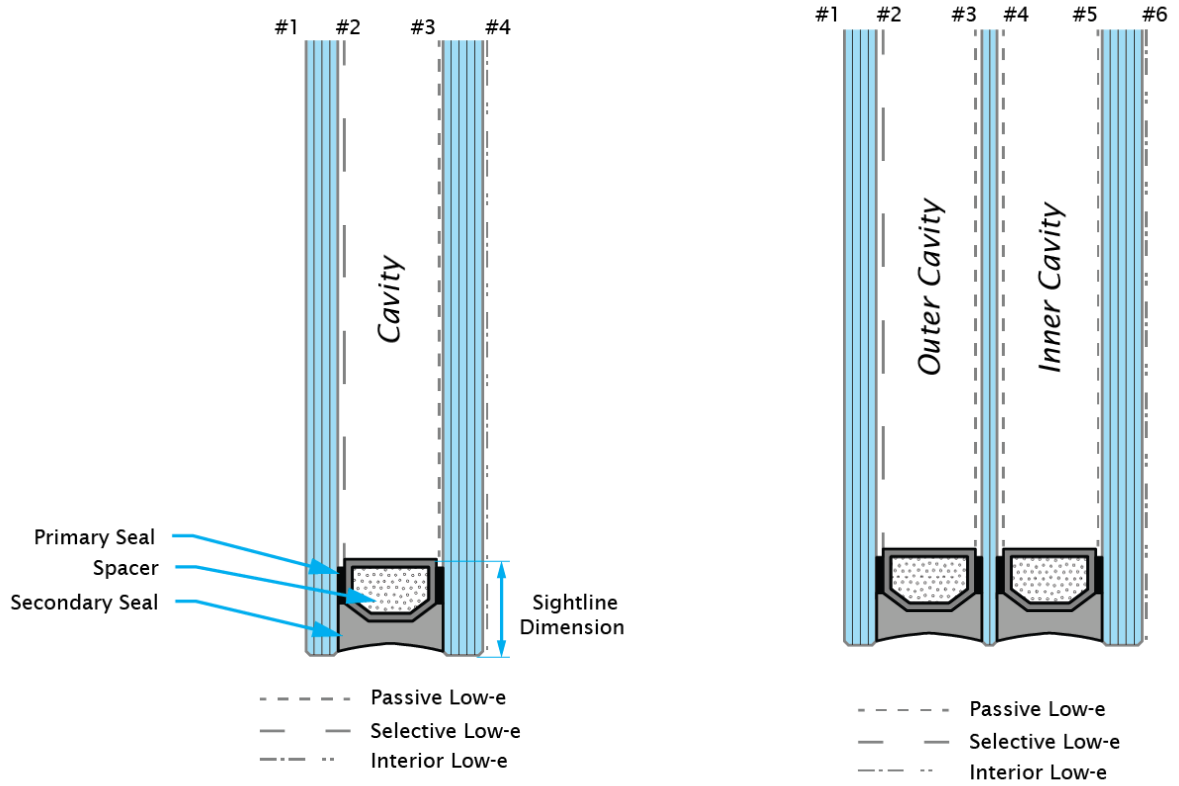
Glass	Clear	Monolithic	Annealed
	Ultra Clear	Laminated – PVB	Heat Strengthened
	Architectural	Laminated – SGP	Fully Tempered
Cavity Gas	Air		Chem. Tempered
	Argon		
	Krypton		
Spacer	Aluminum		
	Stainless Steel		
	Foam	"Warm Edge Spacer"	
	Thermoplastic & Hybrid		
	FRP		
Coating	Passive low-e	
	Selective low-e	- - - - -	
	Interior low-e	— · · · —	
Position	#2 (Low SHGC)		
	#3 (High SHGC)		
	#2 & #4 (Low SHGC)		
	#3 & #5 (High SHGC)		
	+ #4 or #6 (Interior low-e)

Double Glazed Unit (DGU)

Triple Glazed Unit (TGU)

> 5,000,000 Combinations

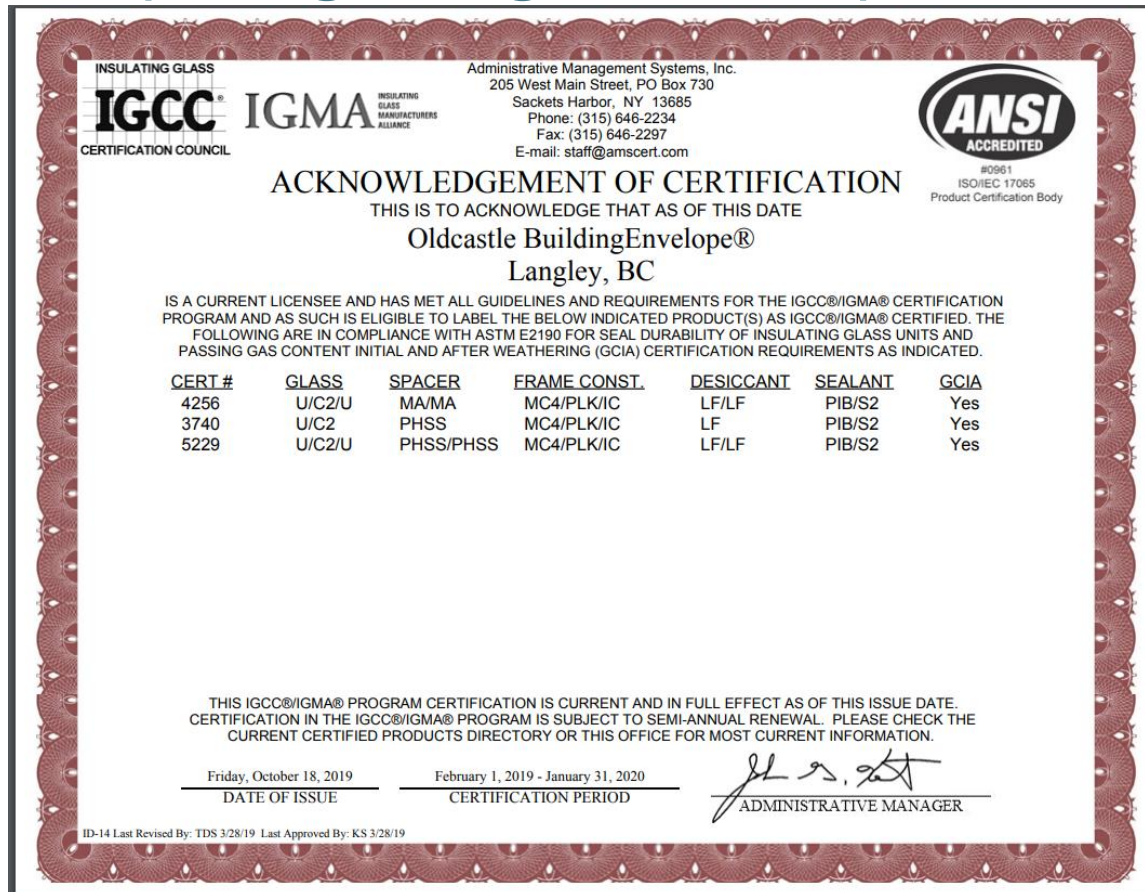
IGMA IGCC IGMAC Certification

- Need to verify label on line
- <https://igcc.org/certified-products.aspx>

- U** Uncoated
 - C2** Sputter Coated, Edge Deleted (Soft)
 - MA** Mill Finish Aluminum
 - PHSS** Plastic Hybrid Stainless Steel
 - MC4** Mechanical Corners x4
 - LF** Loose-fill Desiccant
 - PIB** Polyisobutylene
 - S2** Two Component Silicone
 - GCIA** Measured initial value $\geq 90\%$, $\geq 80\%$ after weathering
- Yes:**
