**Building Science
Summit
New Zealand**

Façade Risk Mitigation

A look to the future based on lessons from the past

Brian Hubbs | P.Eng.
Founder, Principal, Senior Specialist
brian@rdh.com

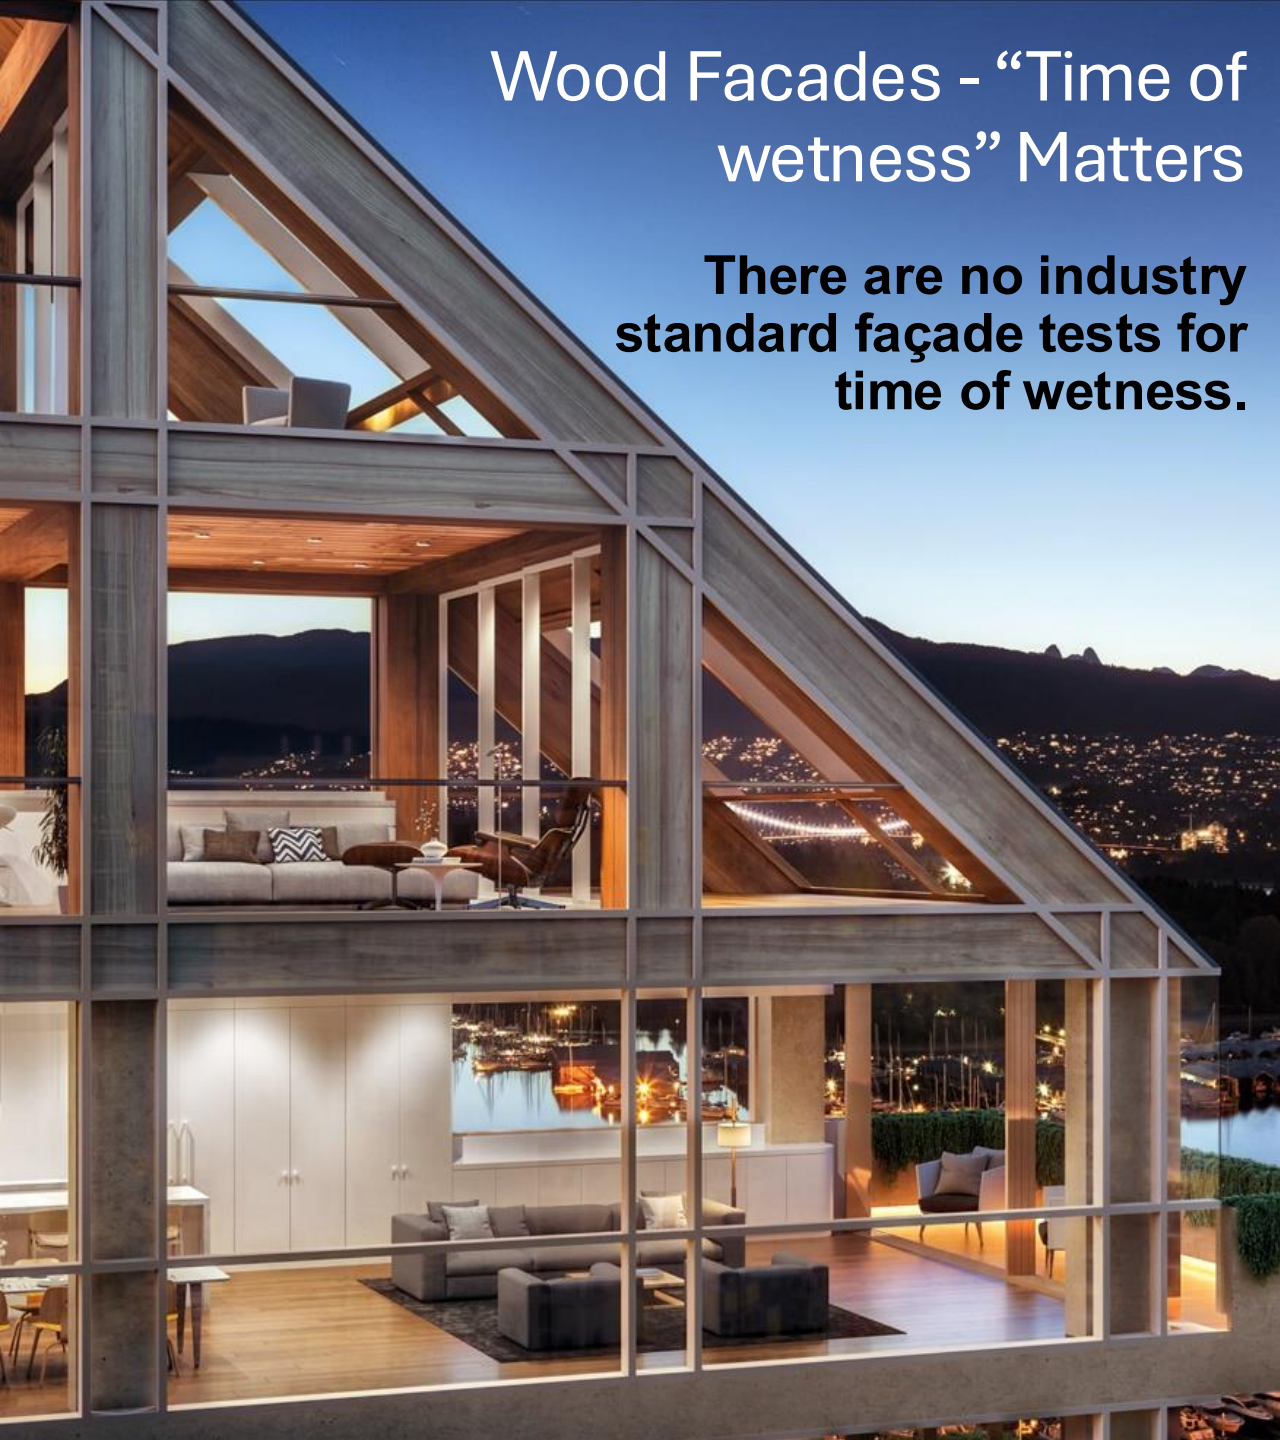
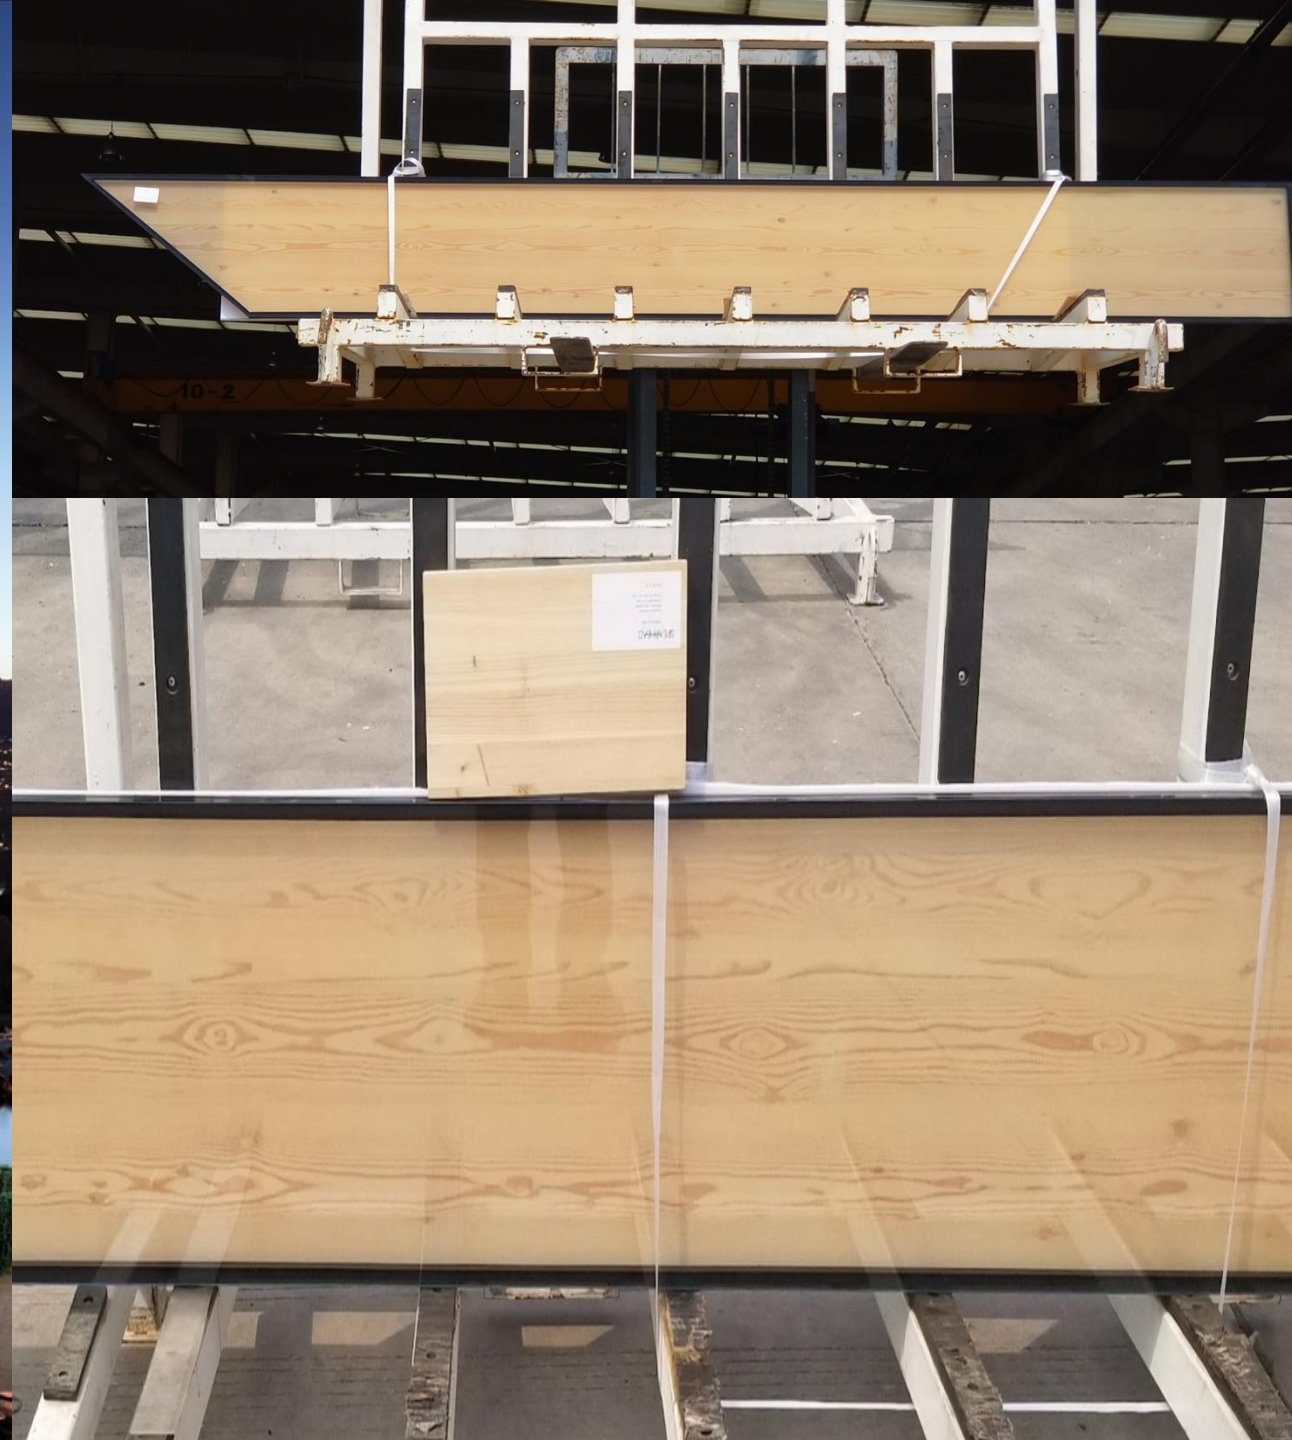
Wood Facades - “Time of wetness” Matters

There are no industry standard façade tests for time of wetness.

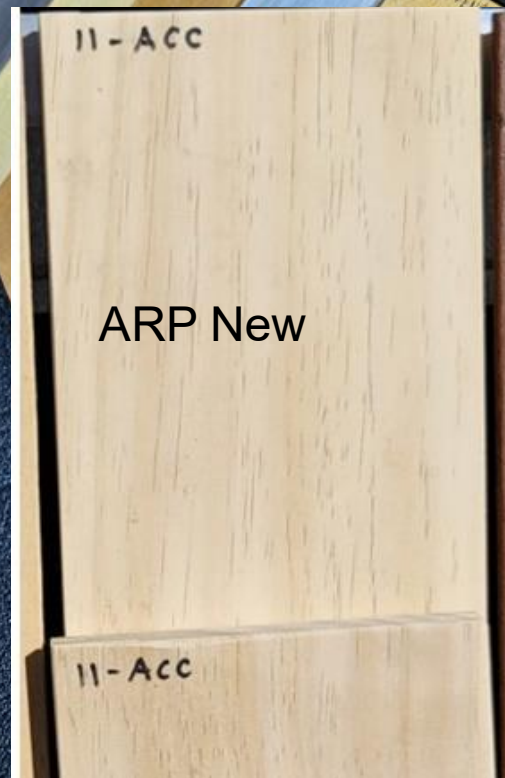
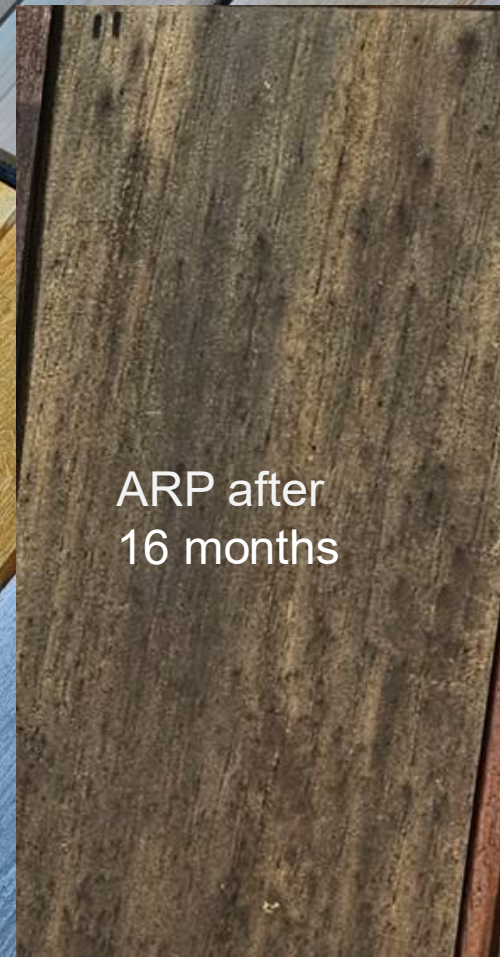
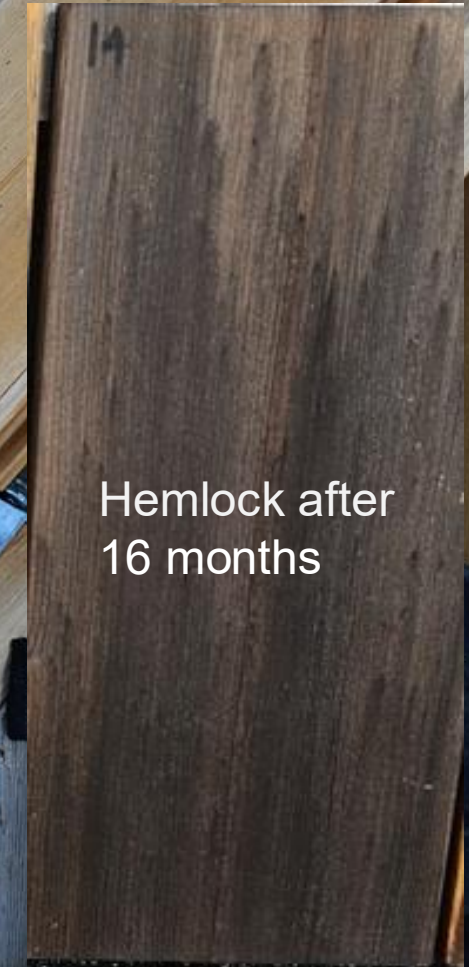
Preservative Treatments ? Acetylated Radiata Pine (ARP) RDH Wood Cladding Weathering Study Observations

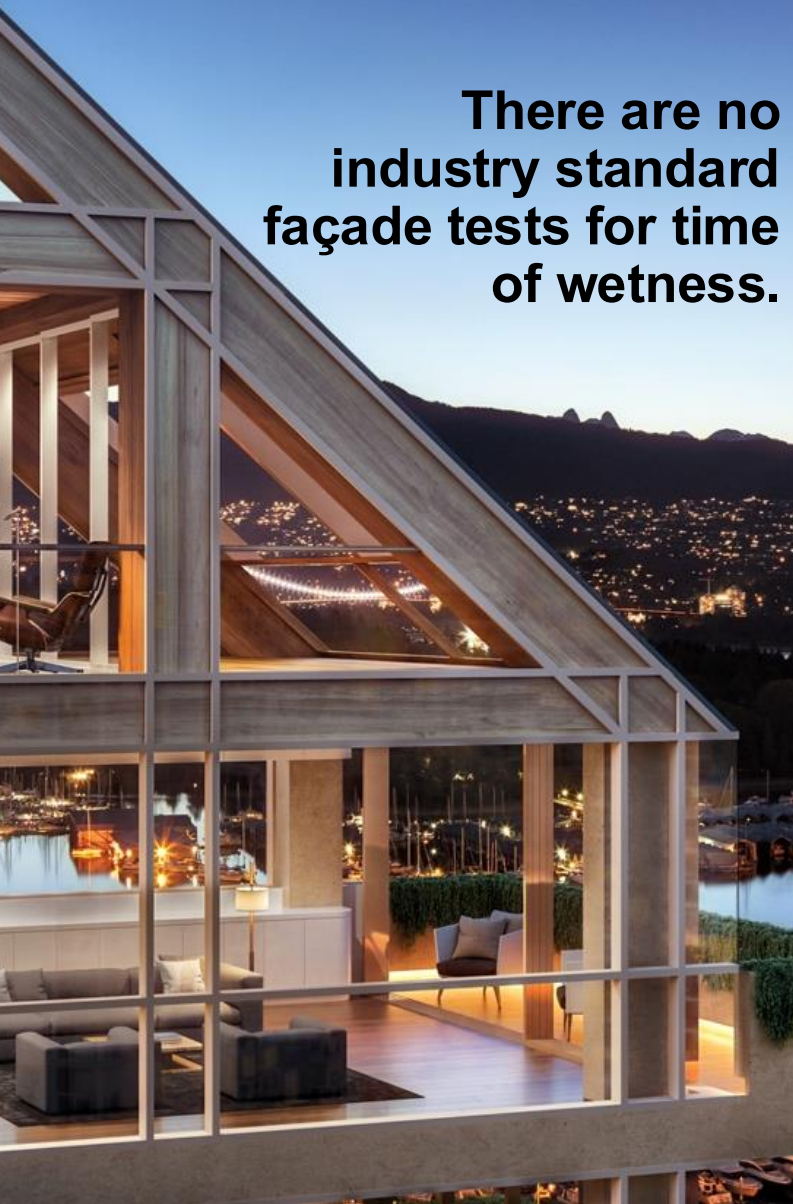
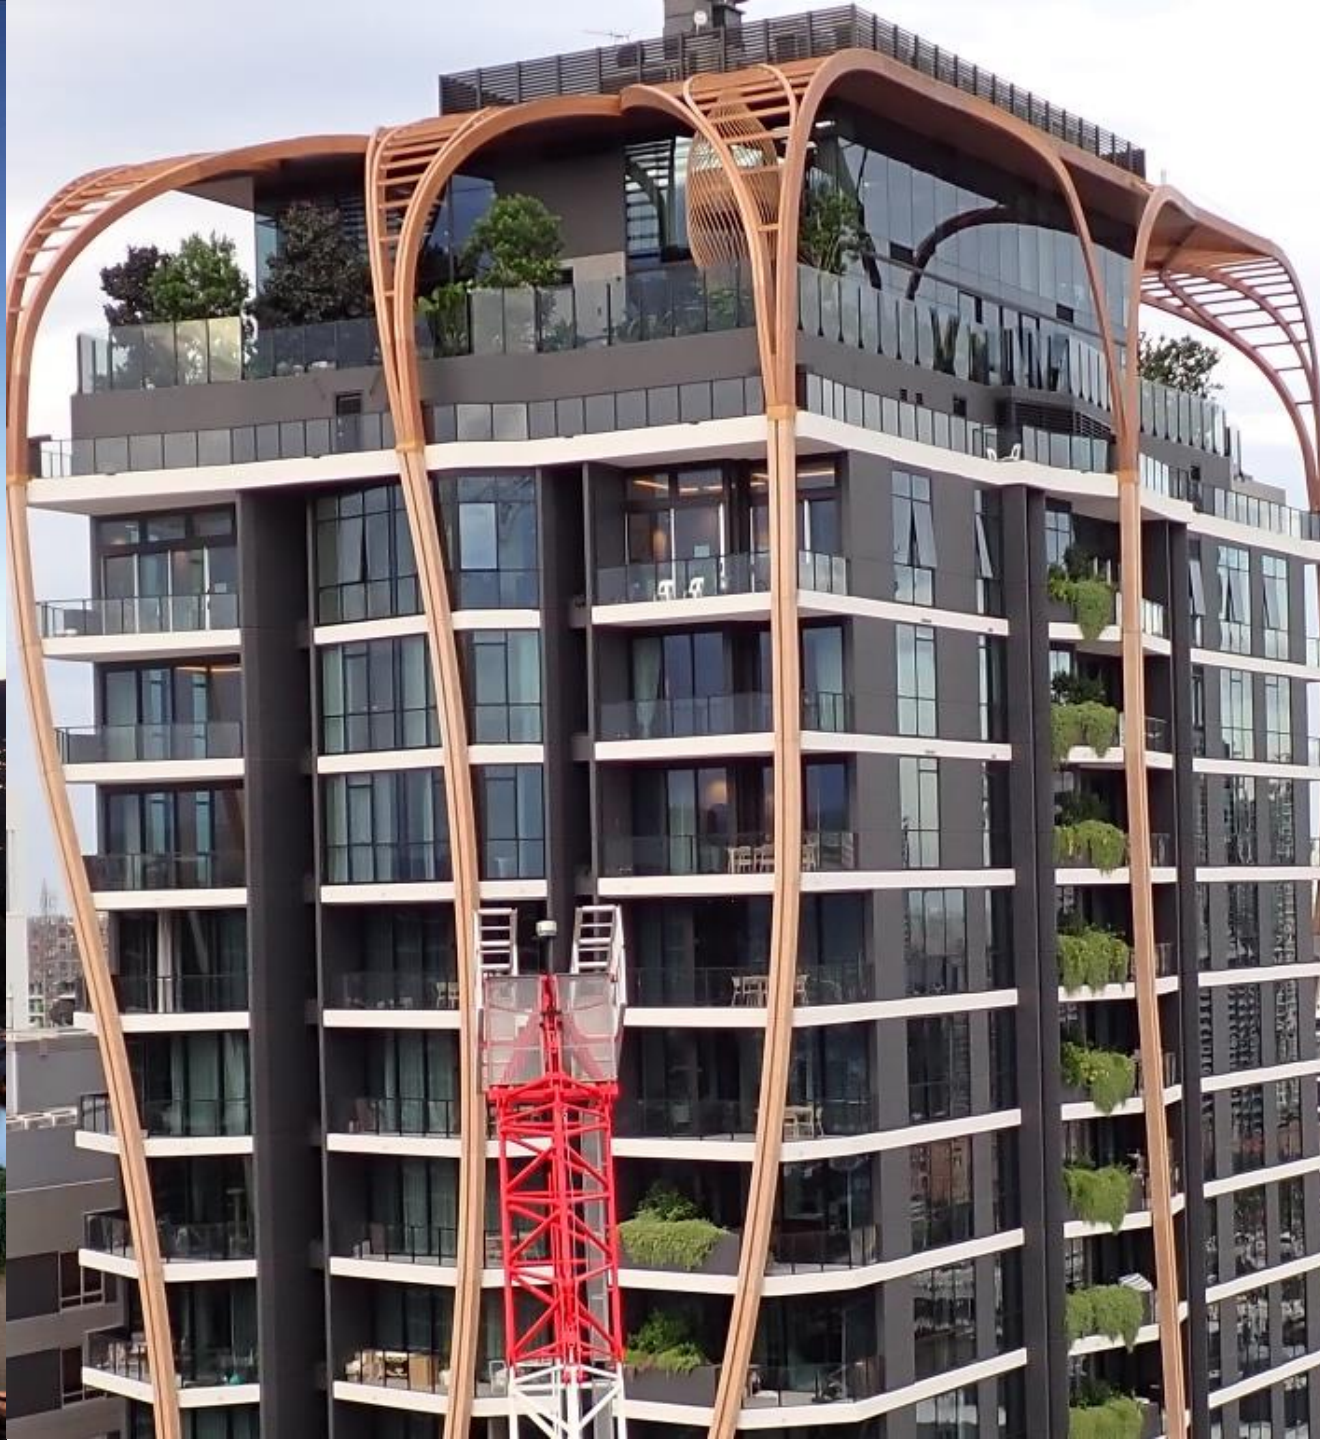
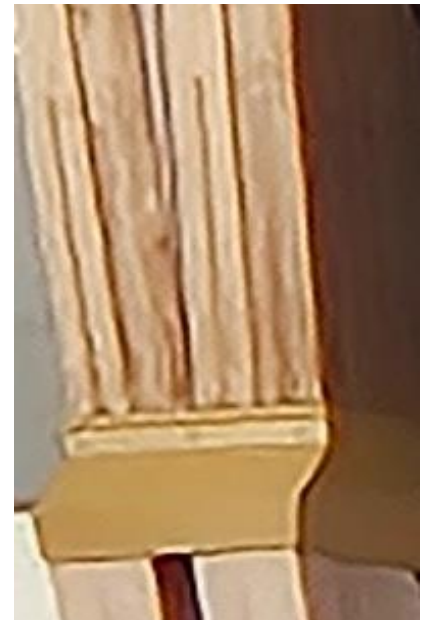
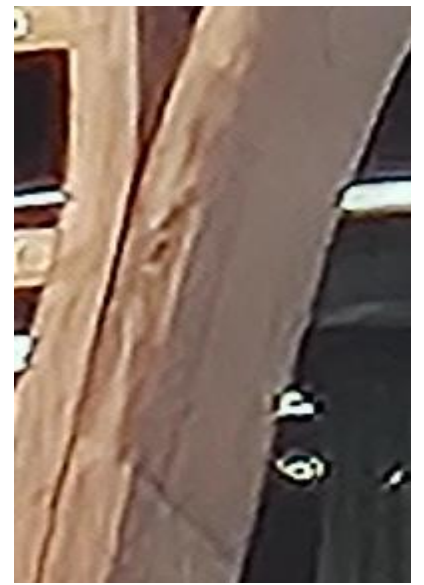
Wood Facades “Time of wetness” Matters

**There are no
industry standard
façade tests for time
of wetness.**

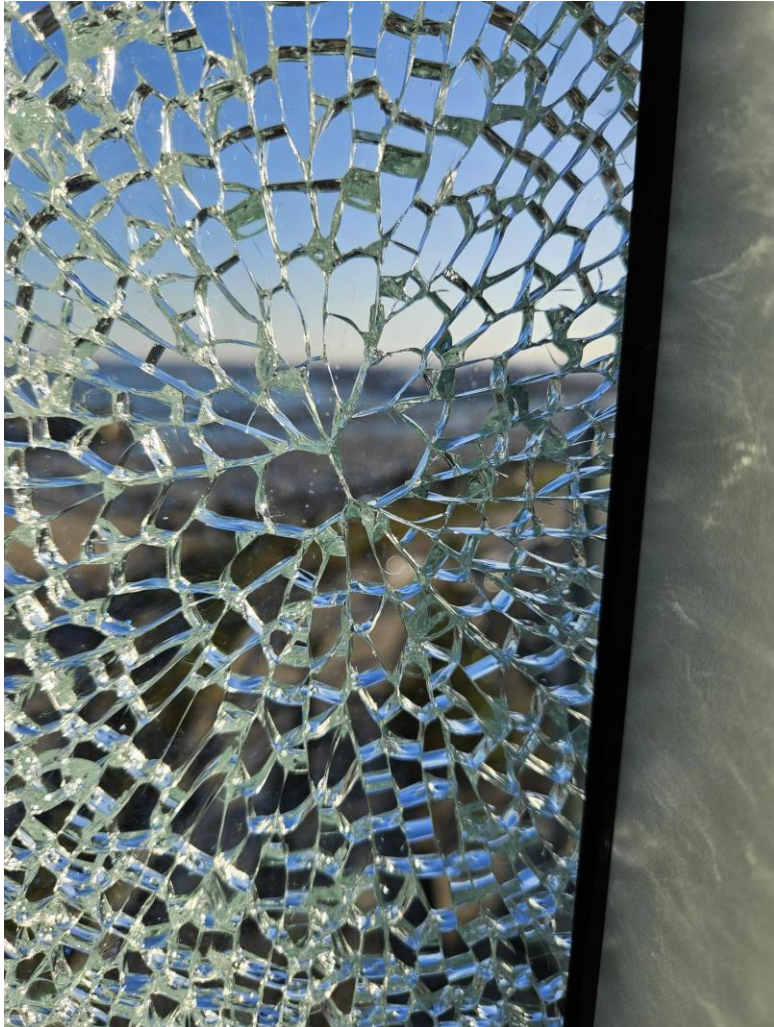
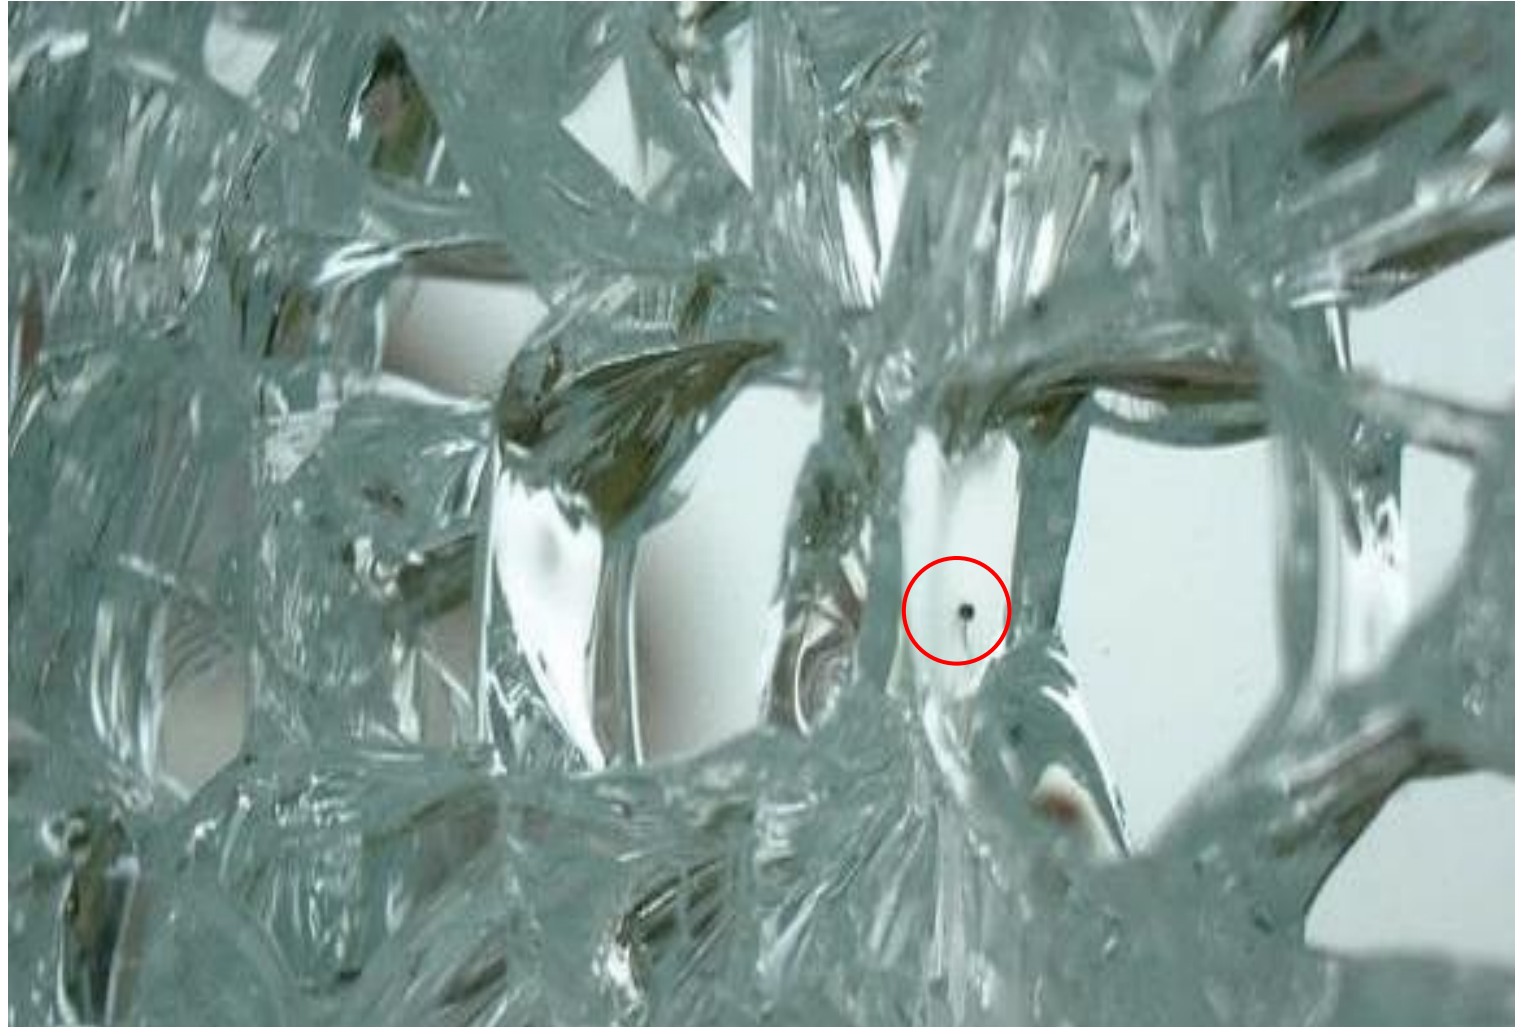
Case Study – Spontaneous Glass Breakage

- Several high-rise residential buildings between 2 and 8 years old.
- Higher buildings with larger tempered glass.
- Between 4 and 40 glazing units on each building have spontaneously broken to date.
- In one case, the occupant was showered with broken glass while he was sleeping. In other cases, broken glass has fallen out of the building onto the street below.
- Mitigation measures deployed (Varies):
 - Hoarding of public spaces below
 - Daily visual inspections of all glazing and rapid replacement program
 - Replacement of high risk glazing above public spaces.

- Under 8 breaks in 1000 is OK – No it is not
- Tempered Low-Iron Glass is similar risk to Tempered Heat Soak Tested glass – Not in my experience..
- Glass etched as heat soak tested has been – Not Always
- 2hr soak time is enough for all sources of glass – Not Always
- Offshore glass has more inclusions ?
- Glass with high % recycled content tends to have more inclusions ?

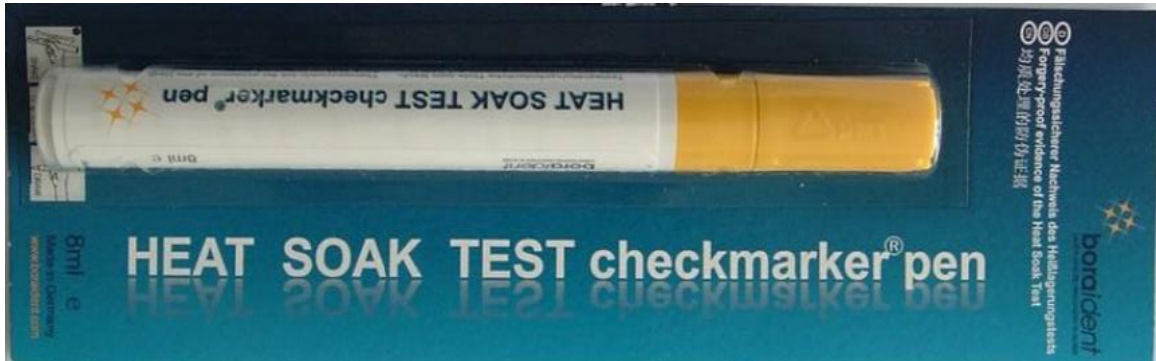
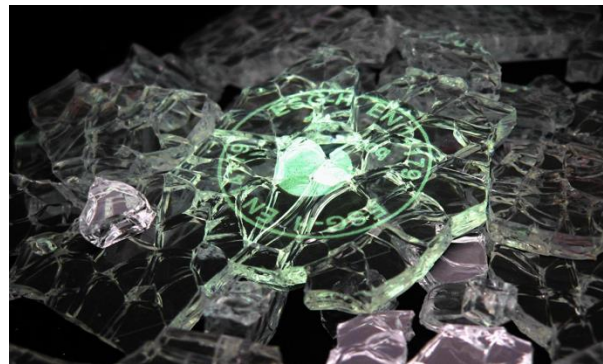
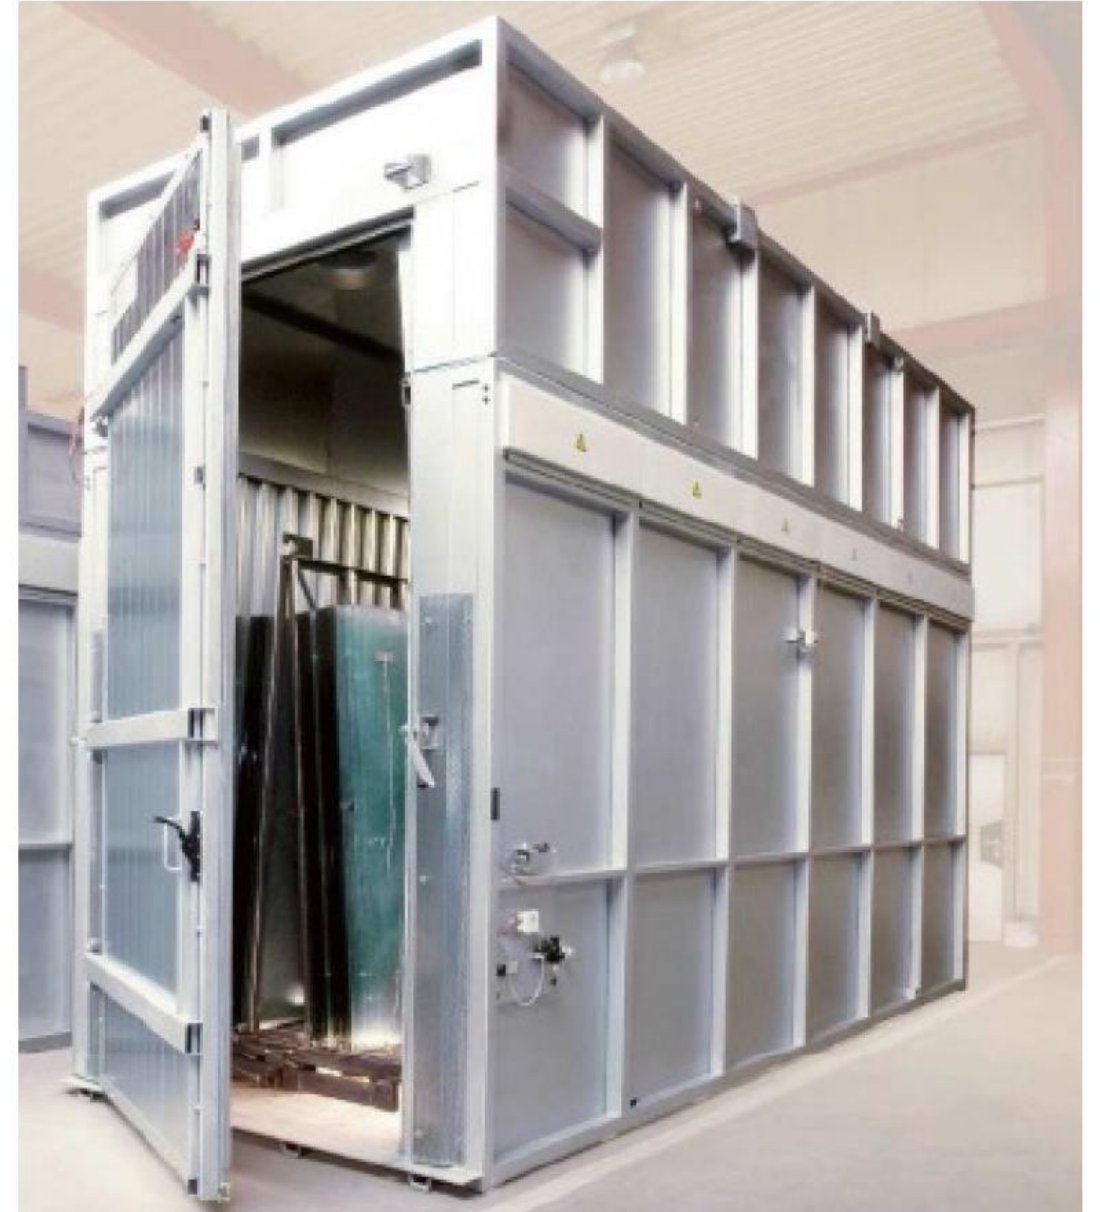
Heat Soak Testing of Tempered Glass

Suggested for larger quantities of glass, high risk glass, structural glass.

European Norm EN 14179 2h.

Eliminates 99% of critical inclusions

Without Heat Soaking: Risk of NiS breakage 1/10 tons (or 5,000 ft² of 5/16")

With Heat Soaking: Risk of NiS breakage 1/1400 tons (or 200,000 ft² of 5/16")

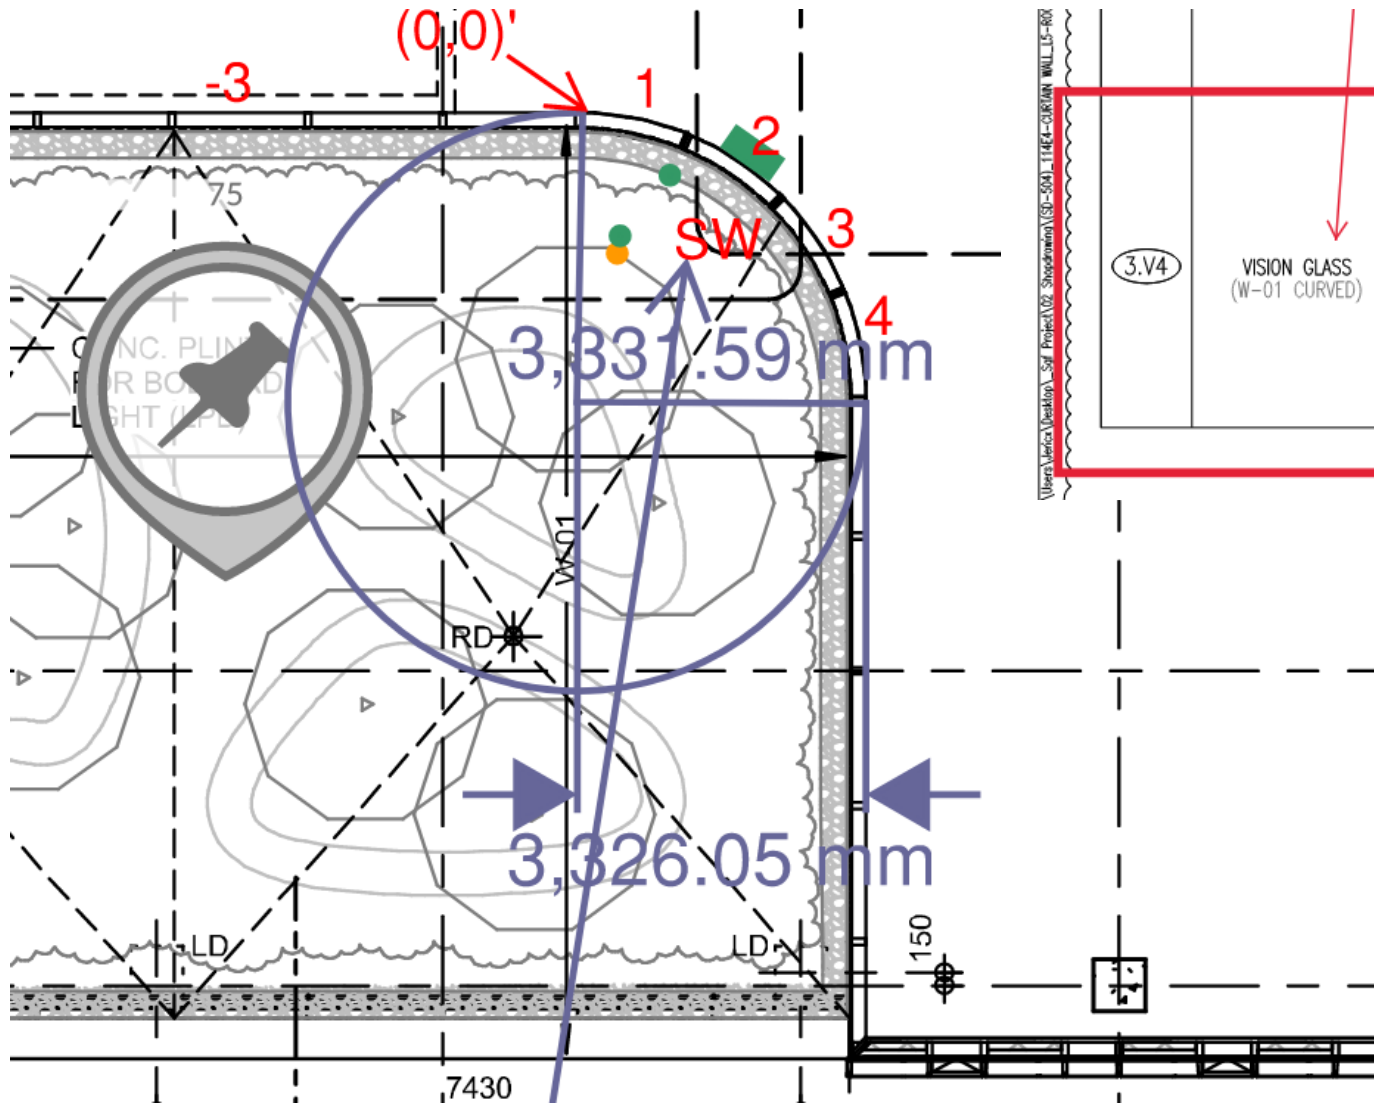
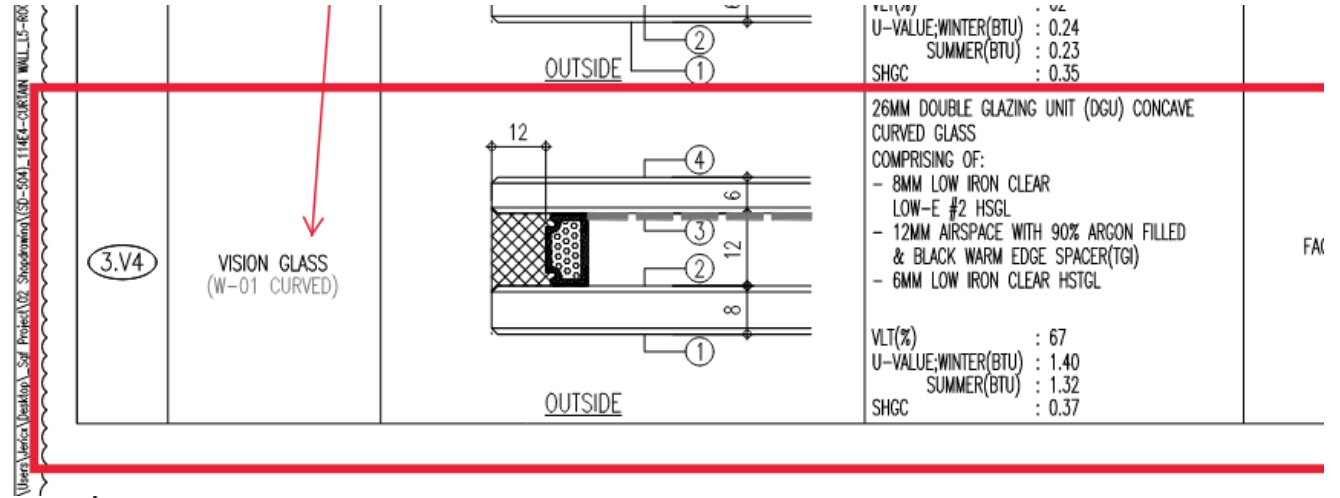
Microclimates

U-VALUE; WINTER (BTU)	: 0.24
U-VALUE; SUMMER (BTU)	: 0.23
SHGC	: 0.35
26MM DOUBLE GLAZING UNIT (DGU) CONCAVE CURVED GLASS	
COMPRISING OF:	
- 8MM LOW IRON CLEAR LOW-E #2 HSGL	
- 12MM AIRSPACE WITH 90% ARGON FILLED & BLACK WARM EDGE SPACER (TGI)	
- 6MM LOW IRON CLEAR HSGL	
VLT (%)	: 67
U-VALUE; WINTER (BTU)	: 1.40
U-VALUE; SUMMER (BTU)	: 1.32
SHGC	: 0.37

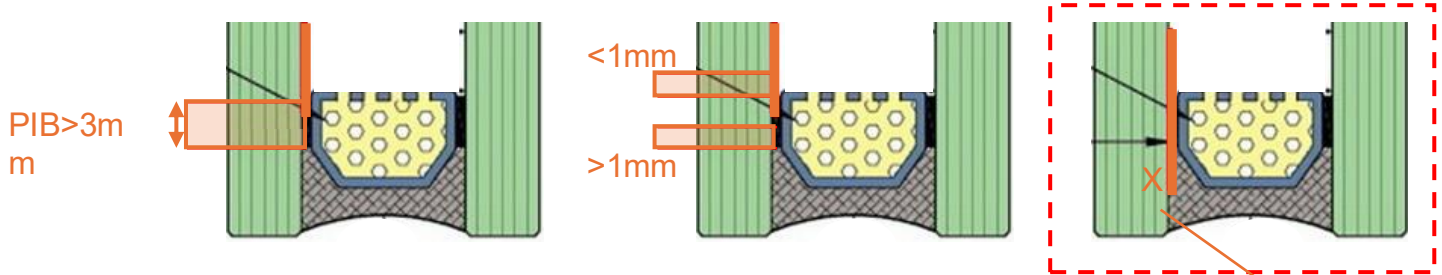
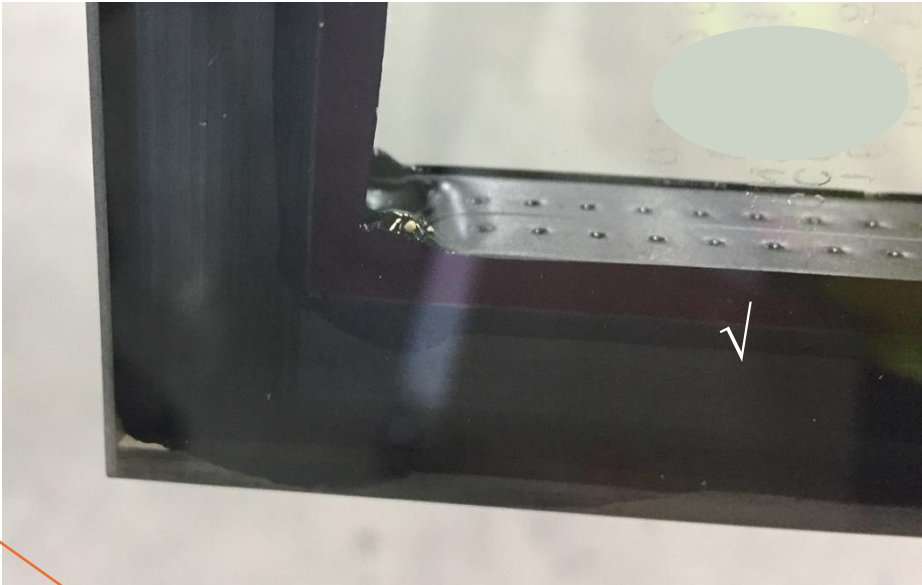
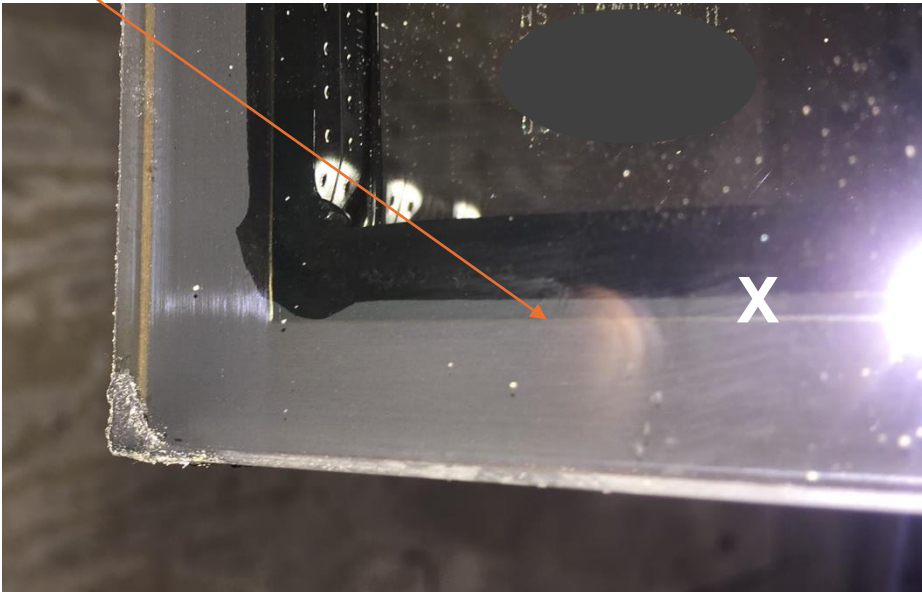
Edge Seal

- Metallic Low-E coatings sensitive to corrosion if not protected from high humidity
- Primary seal (PIB) is the vapor/humidity seal and needs to protect the edge of the coating
- Silicone (secondary seal) very water vapor permeable

Recommended:

Primary Seal (PIB): Minimum width 1/8" (3mm)

Edge Deletion: (1mm) Straightness of edge deletion ±3/64 inch

Butyl-Glass Contact: Minimum Coating Free Glass Contact: 3/64" (1mm) Maximum

Clear Line: 3/64" (1mm)

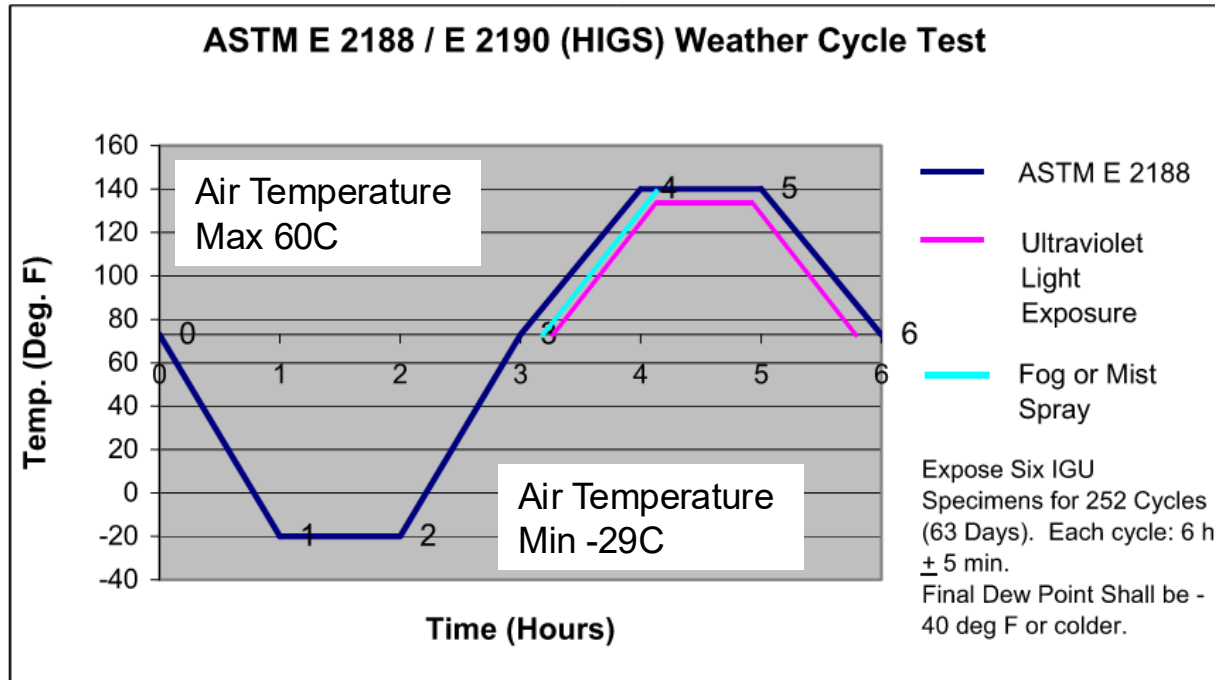
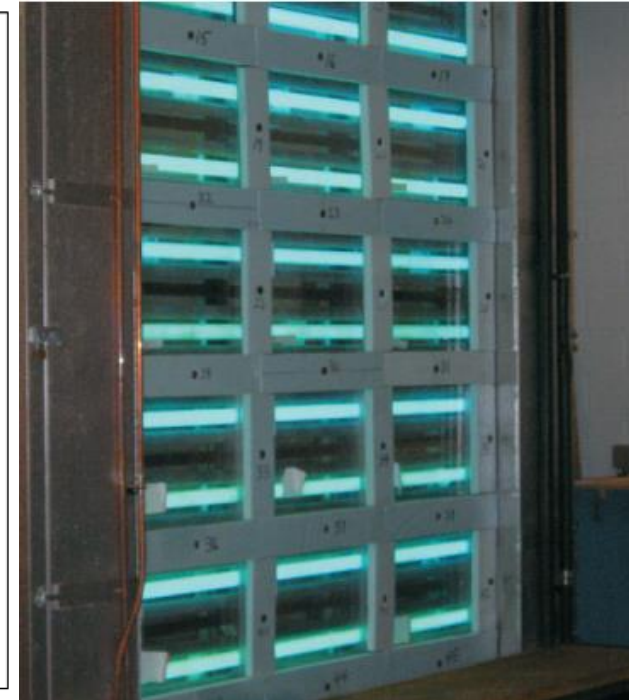
ASTM 2190 – Standard IGU Durability Test (Vision)

- It is suggested that ASTM E2190 applies in the order of 10 years of weathering to the test samples ? In reality, every building is different.

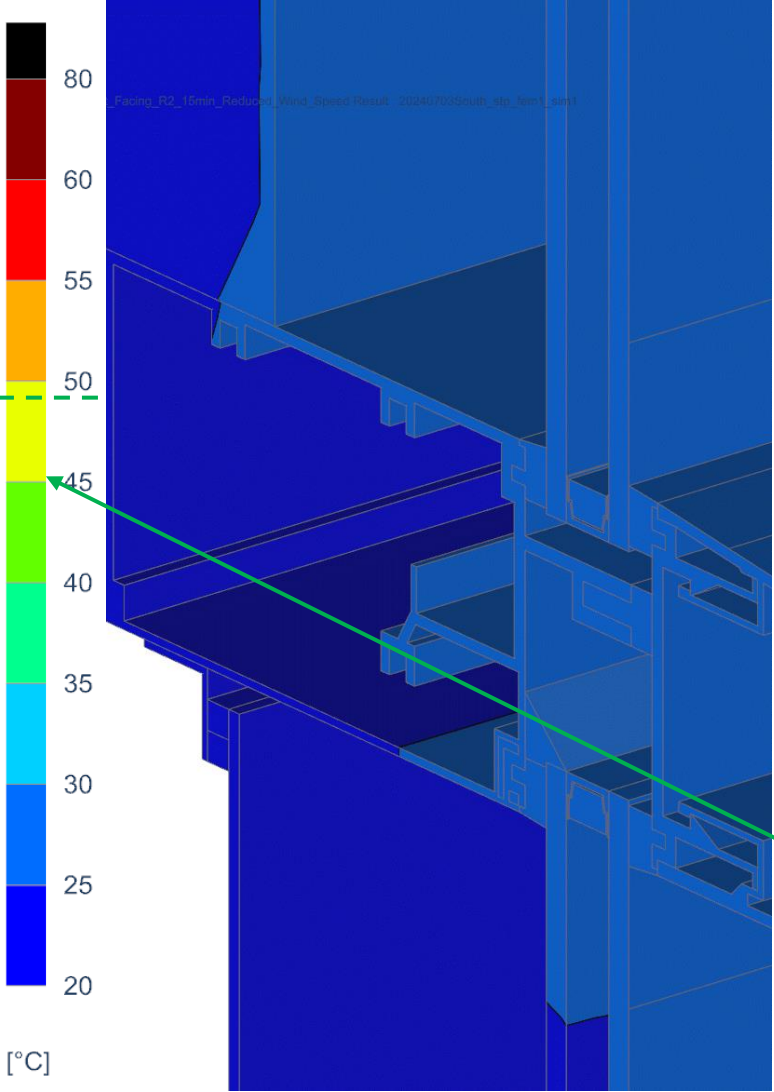
THERMAL PERFORMANCE OF SPANDREL ASSEMBLIES IN GLAZING SYSTEMS RESEARCH (Charles Pankow Foundation)

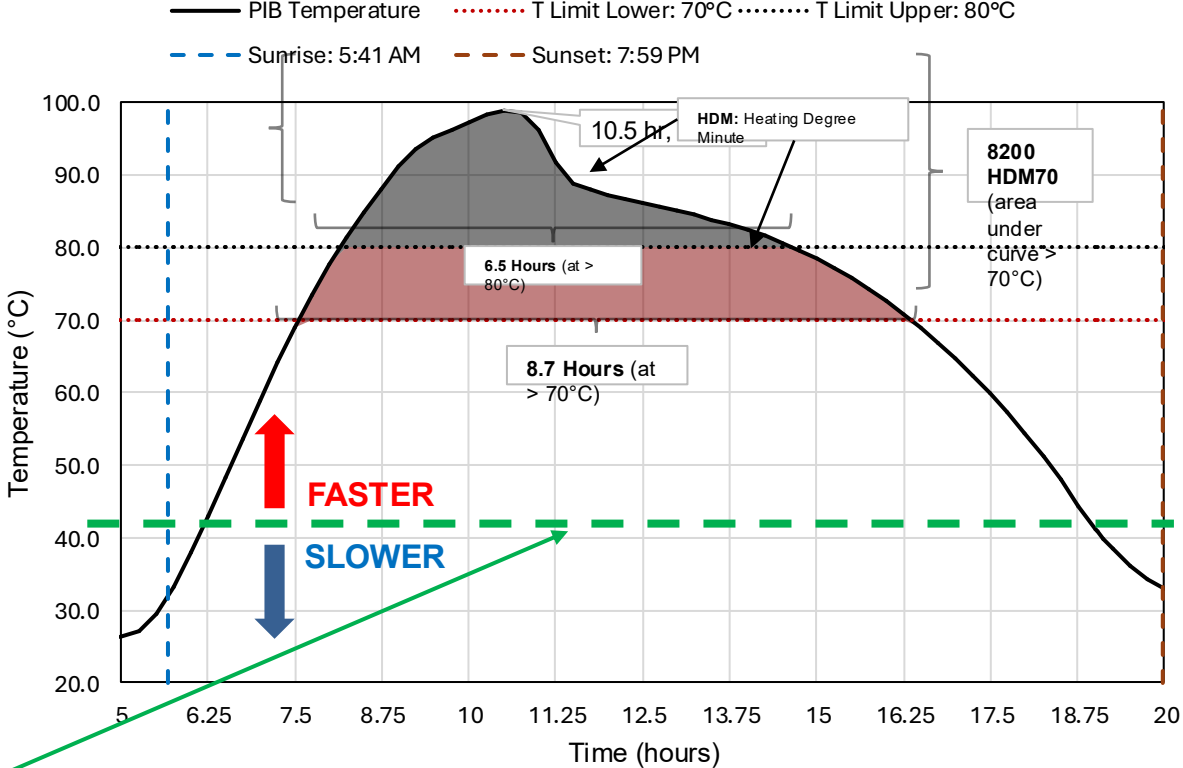
Hermetic Seal Temperature @ Spandrel

Maximum Temperature predicted for Hermetic Seal in ASTM E2190

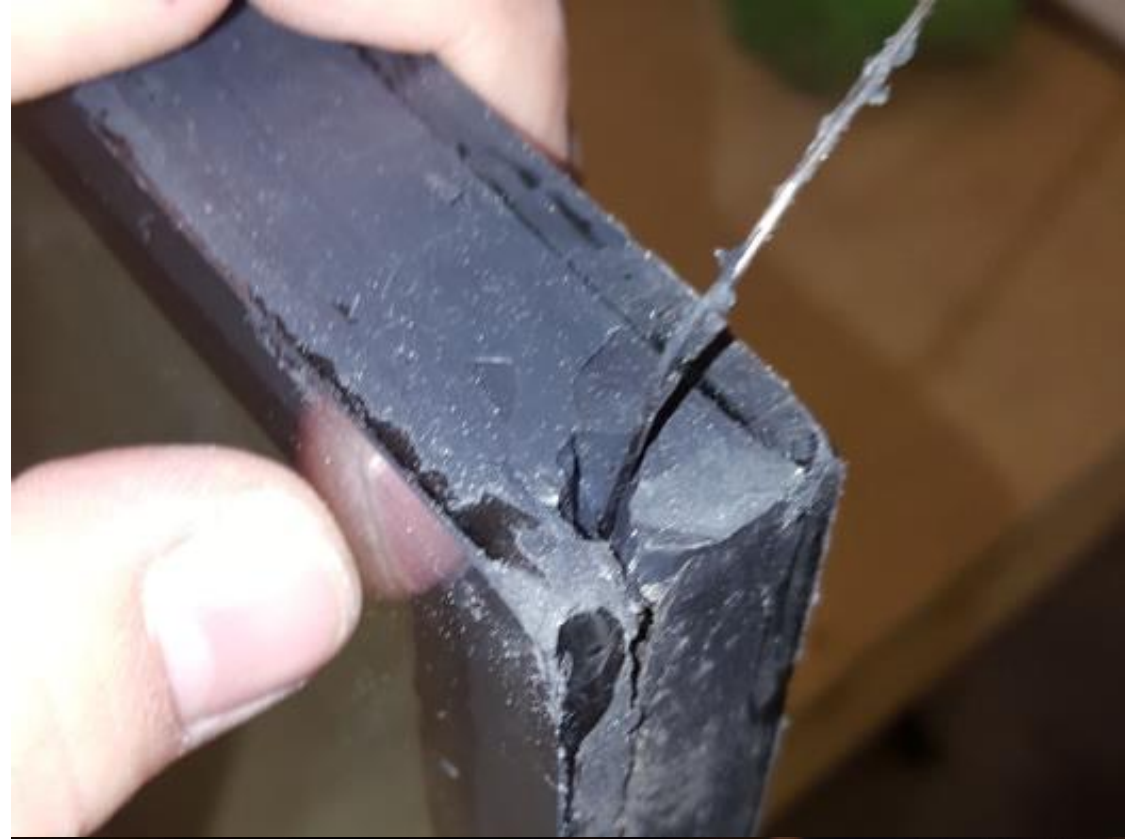
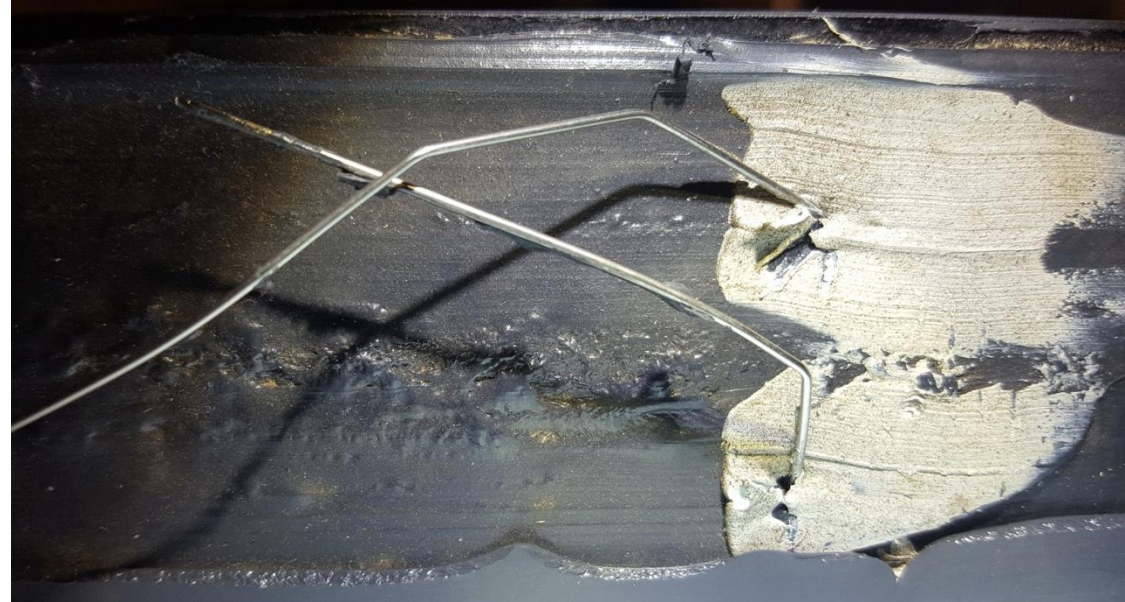
Unsealed/Poorly Sealed/Mangled Capillary Tubes

- Avoid using capillary or breather tubes whenever possible.
- If you must use them, make sure all vent tubes and capillary tubes are sealed.
- Make sure manufacturer is certified for and has tested IGU's to ASTM2190 with breather tubes and proposed sealing method.
