**Building Science
Summit
New Zealand**

Façade Risk Mitigation

A look to the future based on lessons from the past

Brian Hubbs | P.Eng.
Founder, Principal, Senior Specialist
brian@rdh.com

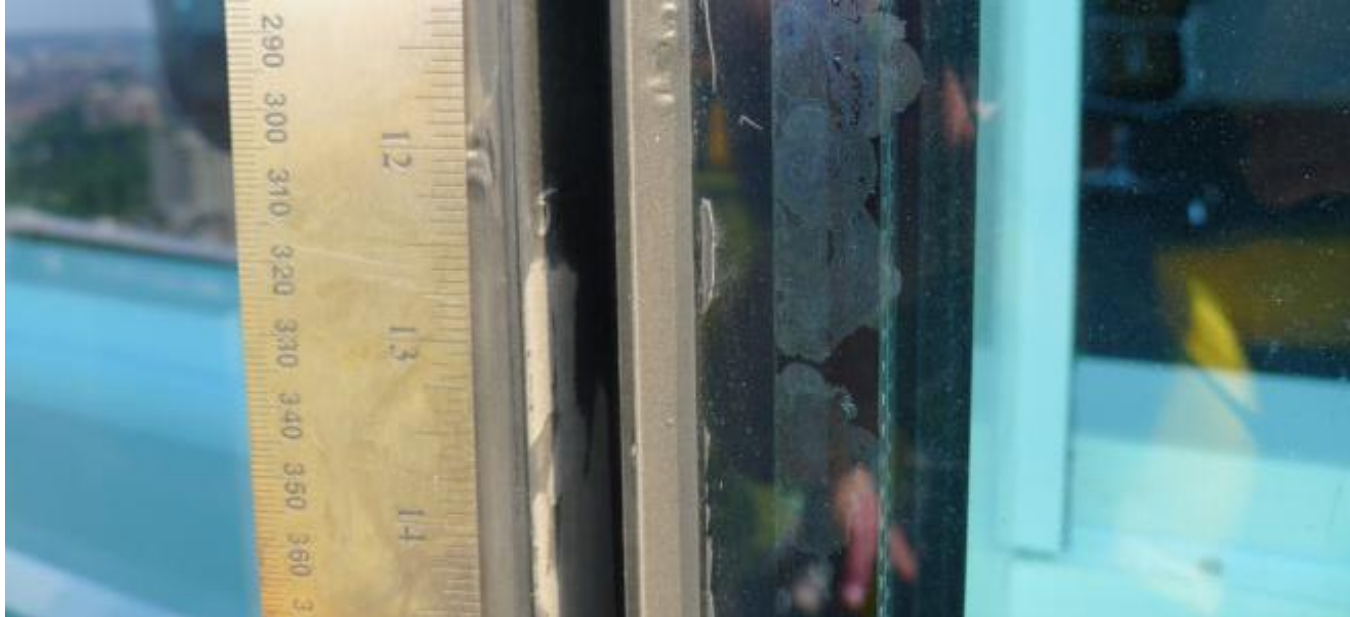
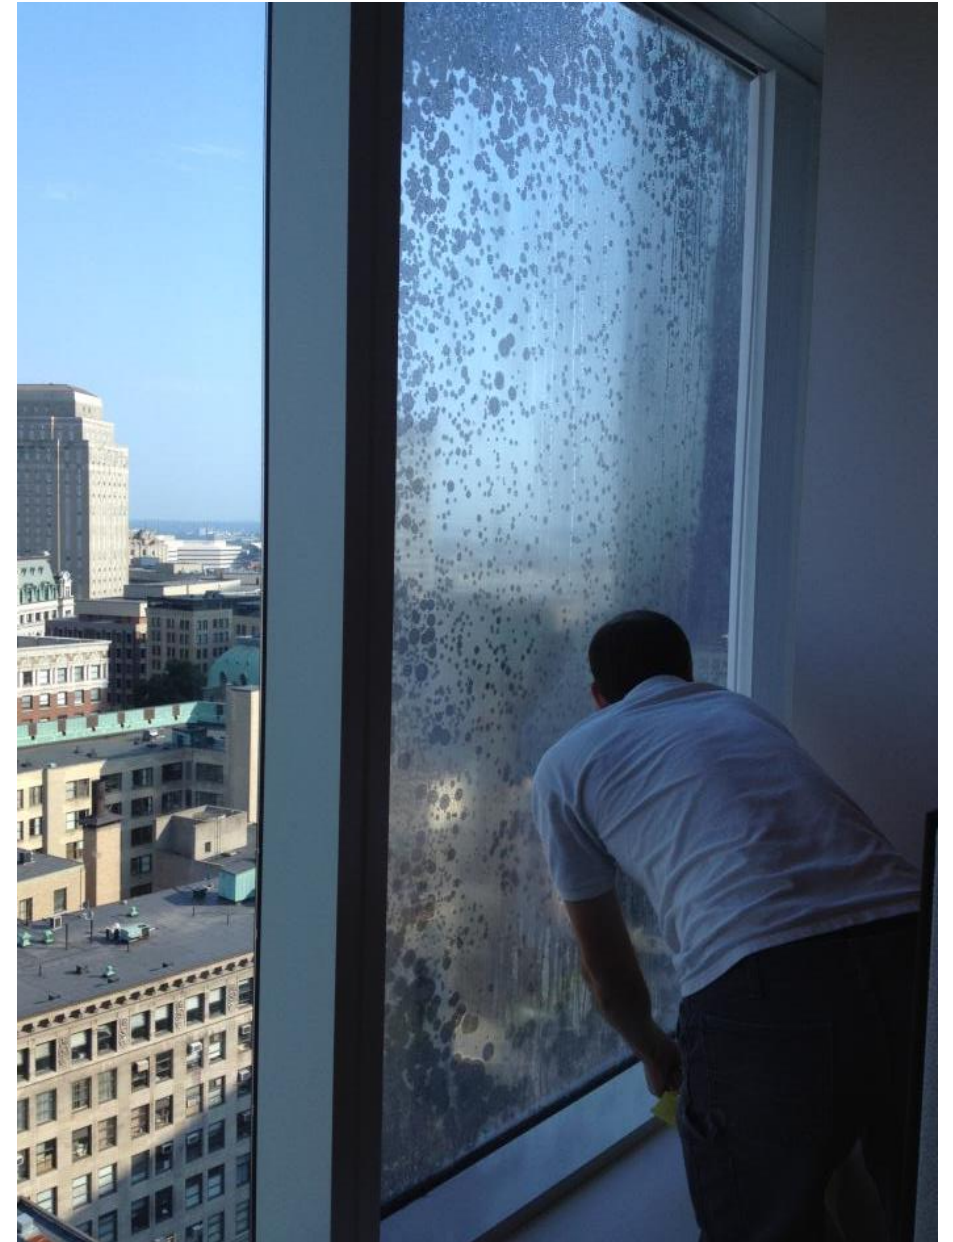
Systemic Highrise IGU Glazing Failure

- Glazed Aluminum Unitized CW
- 10-yr old – Due Diligence Inspection
- Low-e failure | Multiple / Progressing Failures
- No Reported Water Intrusion

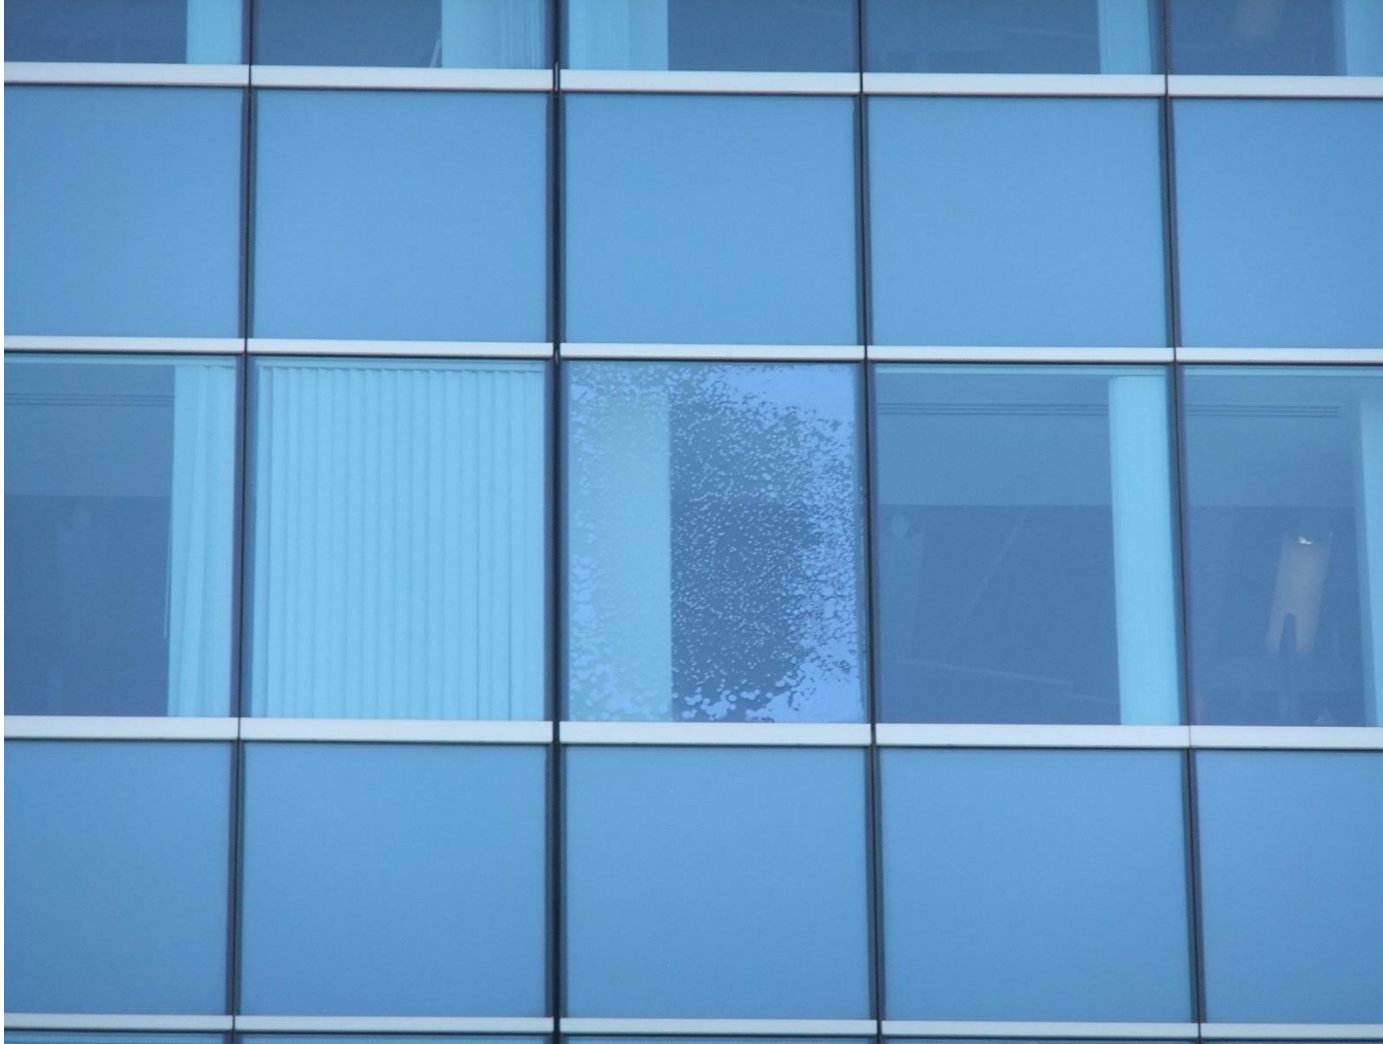
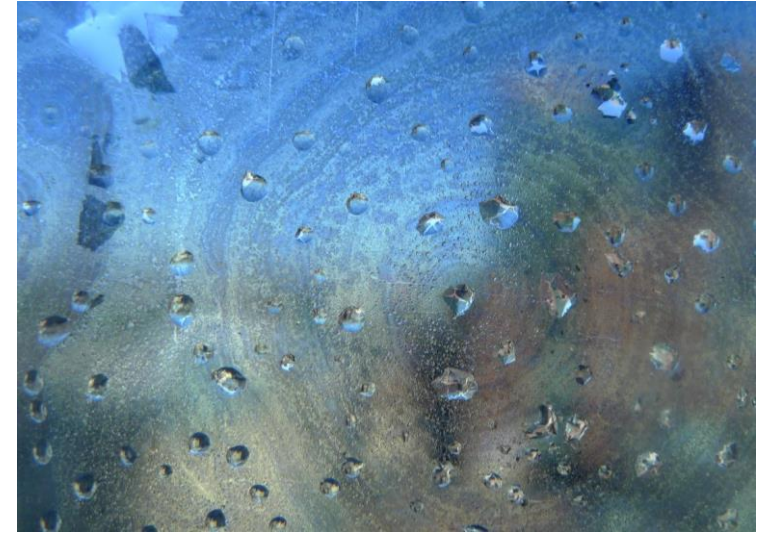
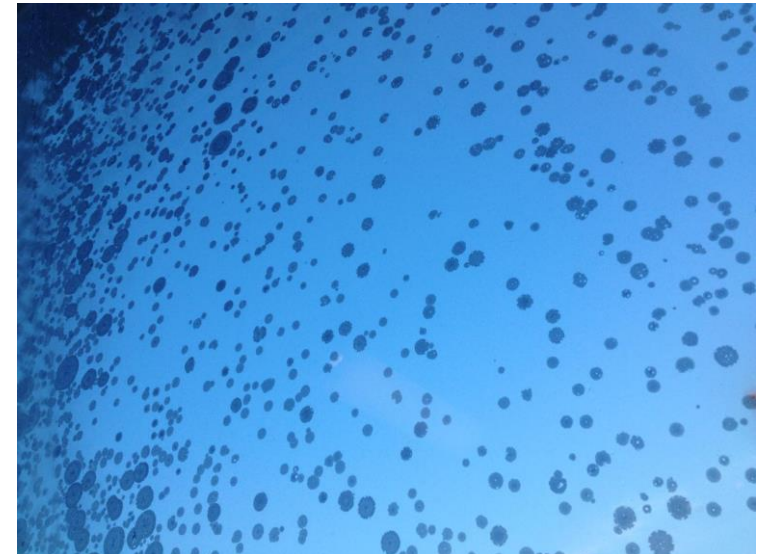
Case Study: Corrosion of Low-E

- Metallic Low-E coatings sensitive to corrosion if not protected from high humidity
- Primary seal (PIB) is the vapor/humidity seal and needs to protect the edge of the coating
- Silicone (secondary seal) very water vapor permeable

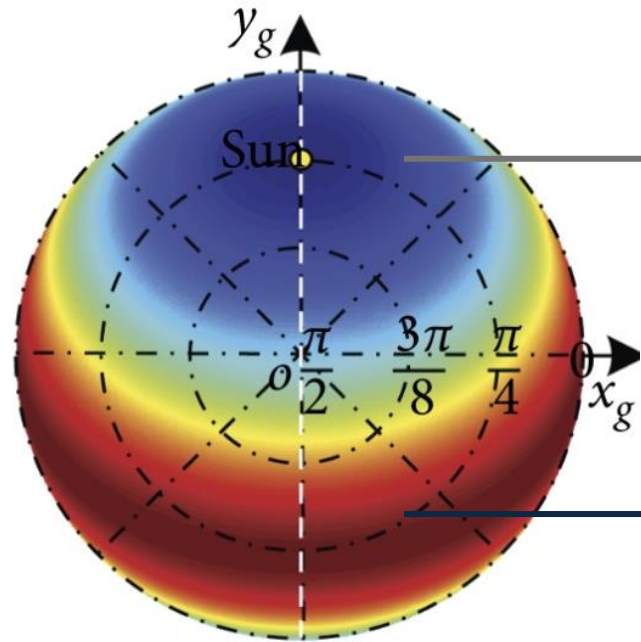
Rayleigh Sky Model

Low Sky polarization

High Sky polarization

Degree of Polarization (DOP)

Highest Potential for Visibility of Anisotropy on building elevations facing highly polarized portions of the Sky Dome

Direction of Sky Polarization

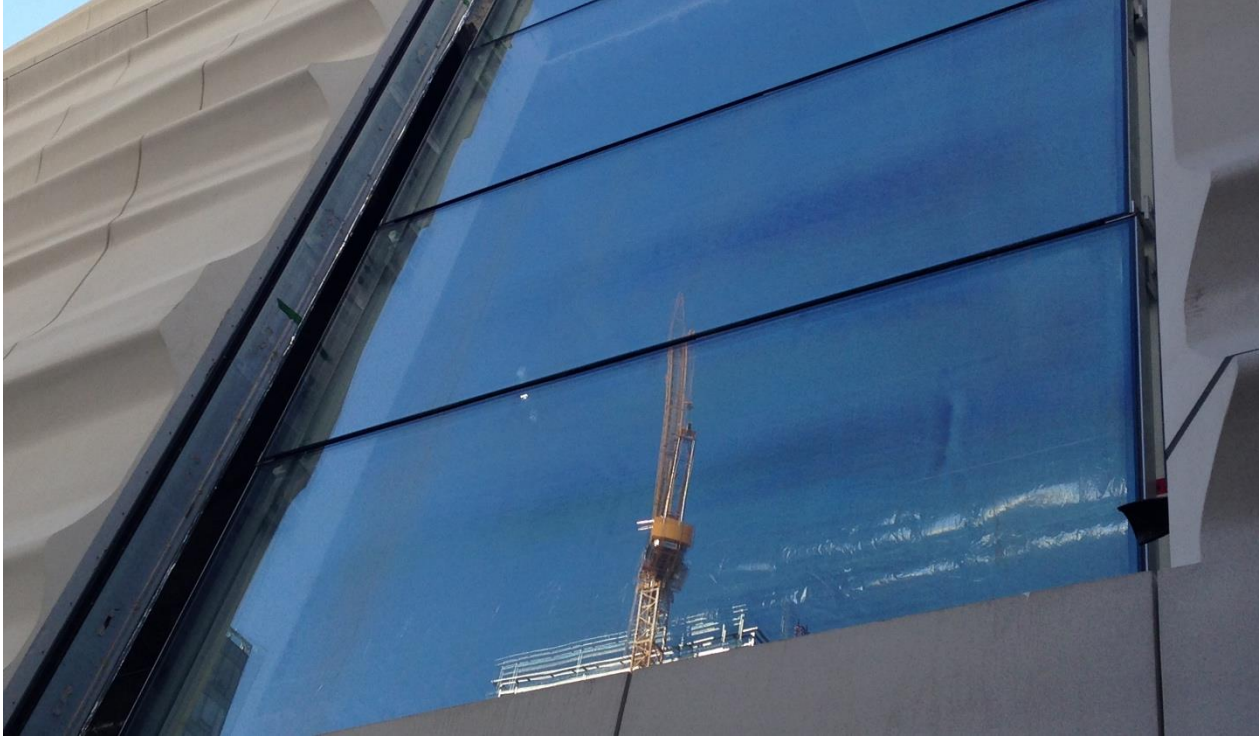
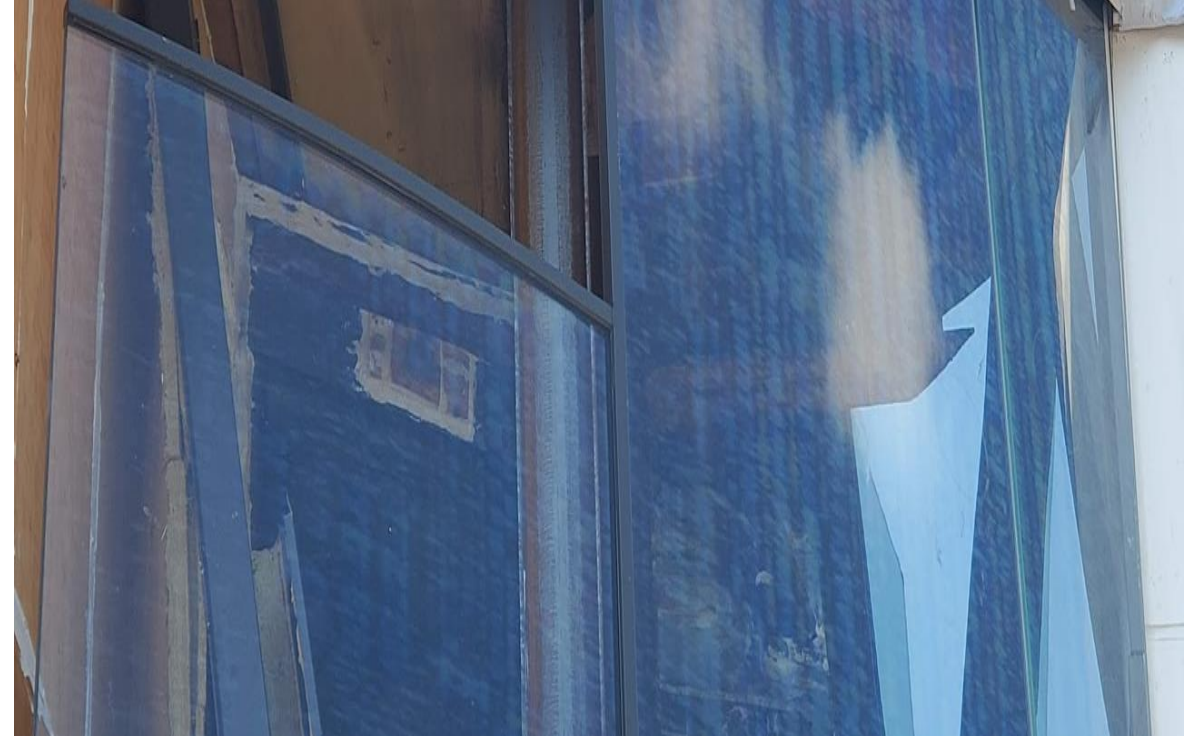
What we do not want to see...

Regular patterning is inevitable.

Stripes,

Blotches,

Change of Direction,

excessive Retardation

..should be avoided.

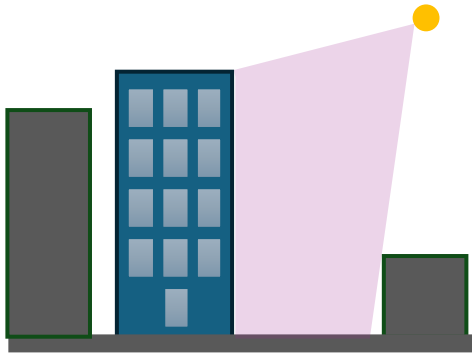
Wide angle of sun exposure

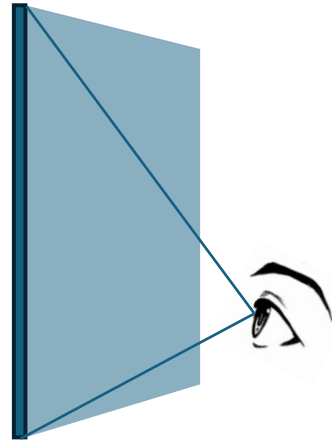
Shallow viewing angle

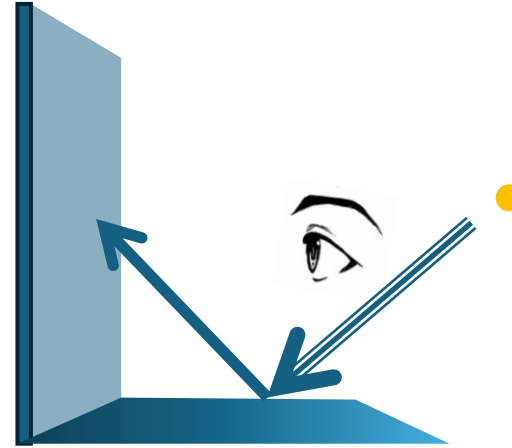
Reflective surfaces

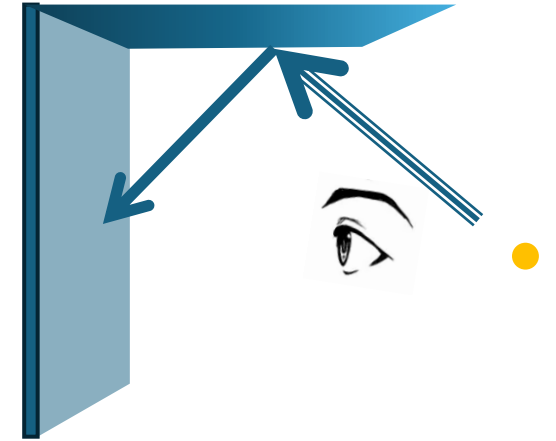
Specular surface materials

+ thick glass substrates, multiple glass layers, coating selection, complex shapes, larger glass

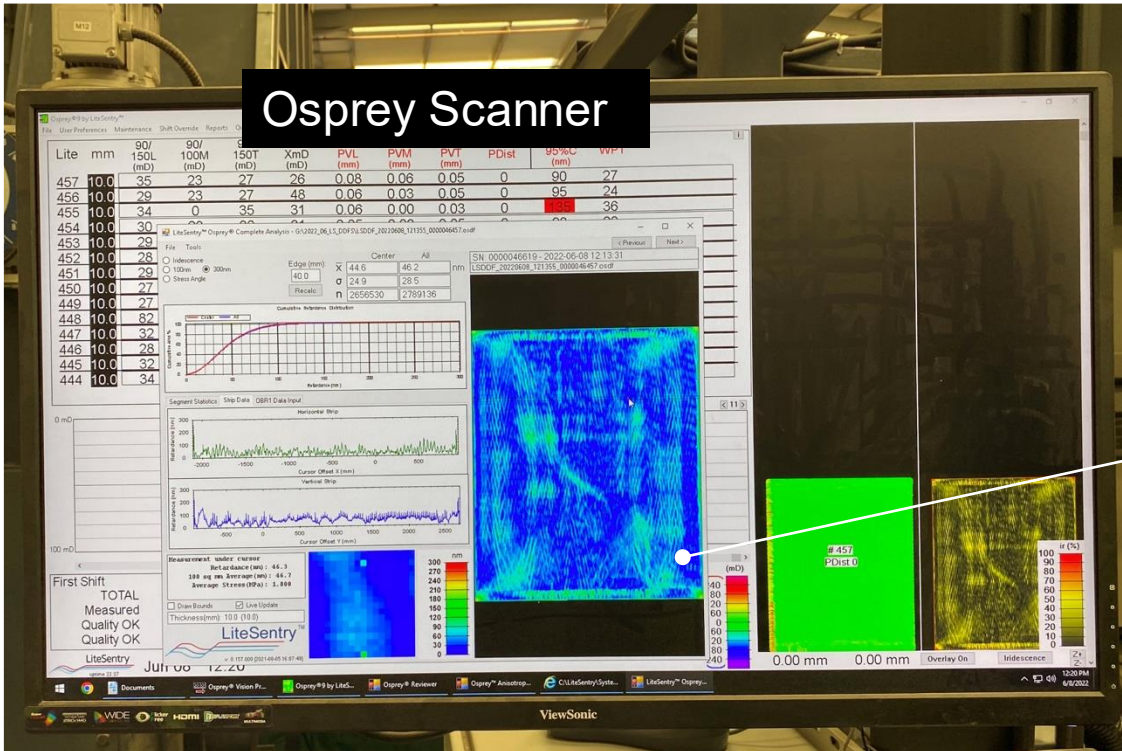
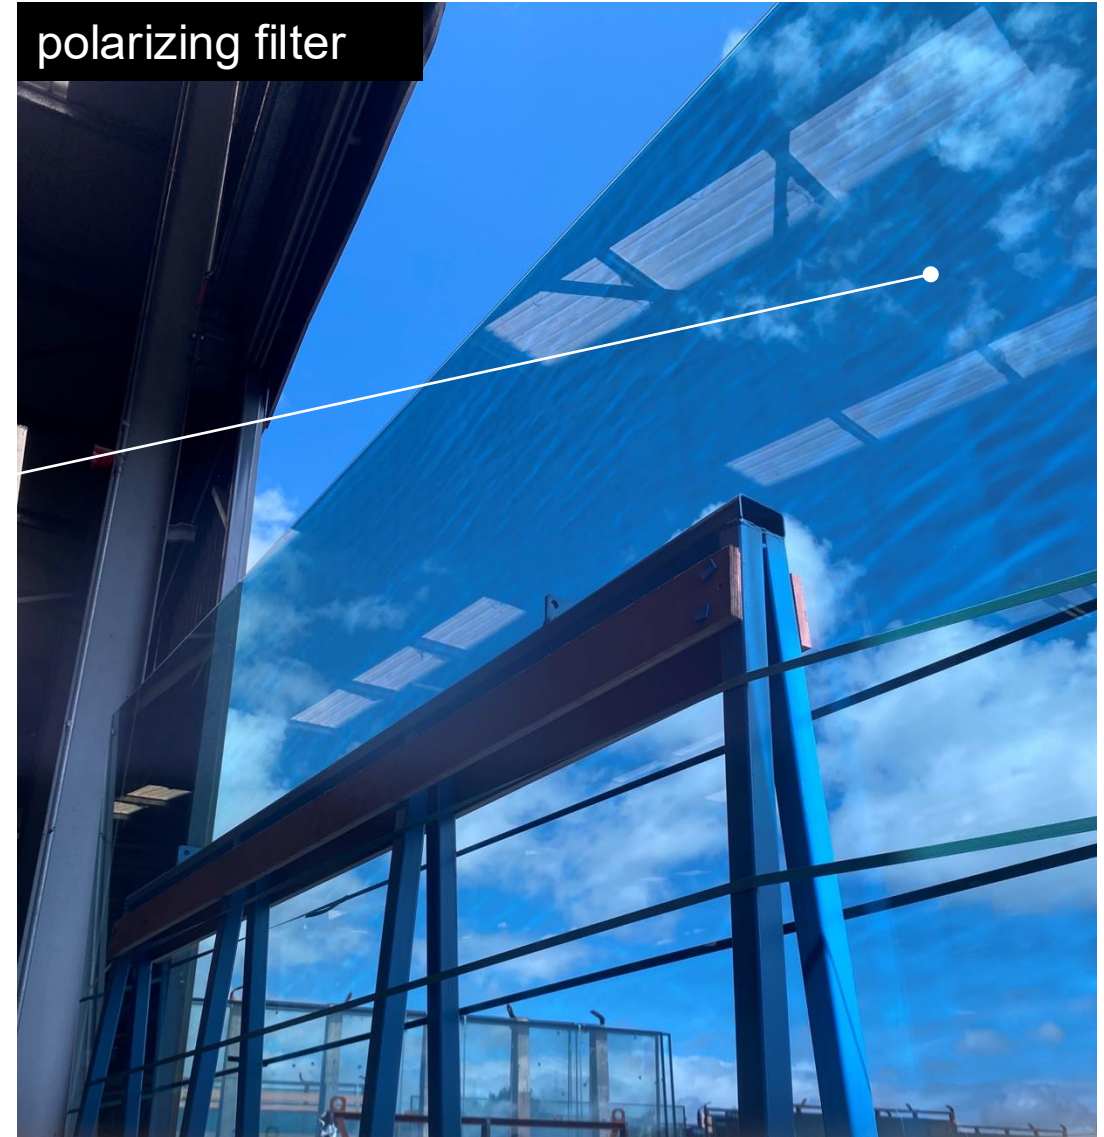
Anisotropy – Control

Glass Thickness	Not Noticeable (Sedak)	DIN SPEC 18198			ASTM C1901
		Class A	Class B	Class C	
6mm	40	70	70-95	>95	120
8mm	50	80	80-120	>120	
10mm	60	95	95-140	>140	250
12mm	80	115	115-165	>165

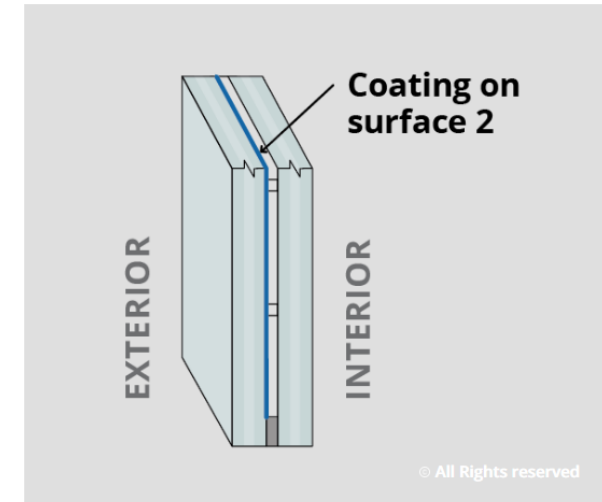
Standard vacuum insulated glass

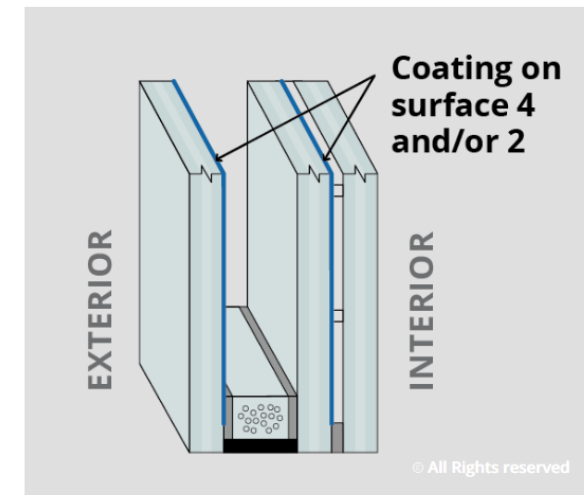
Hybrid vacuum insulated glass

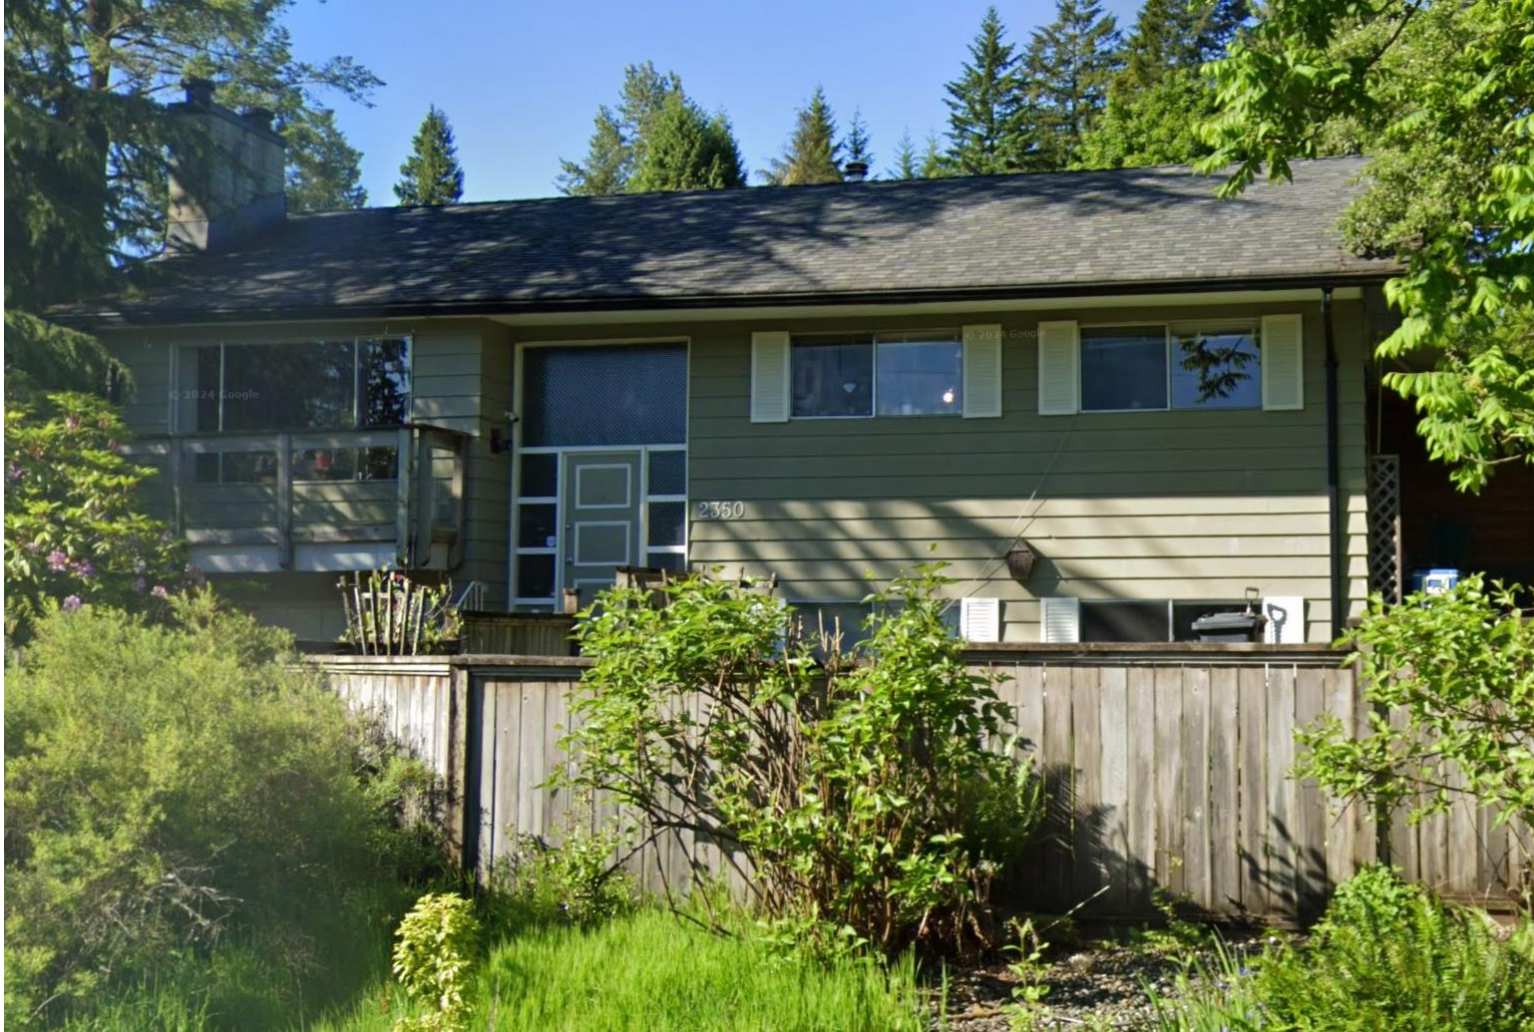
Before – Single Glazed

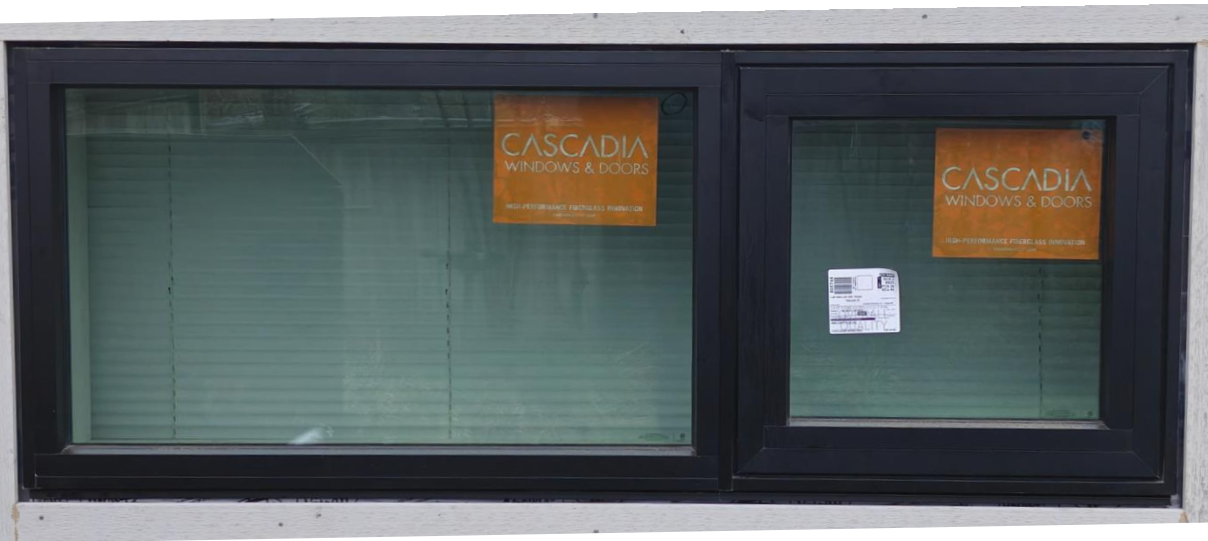
After – Triple Hybrid VIG in

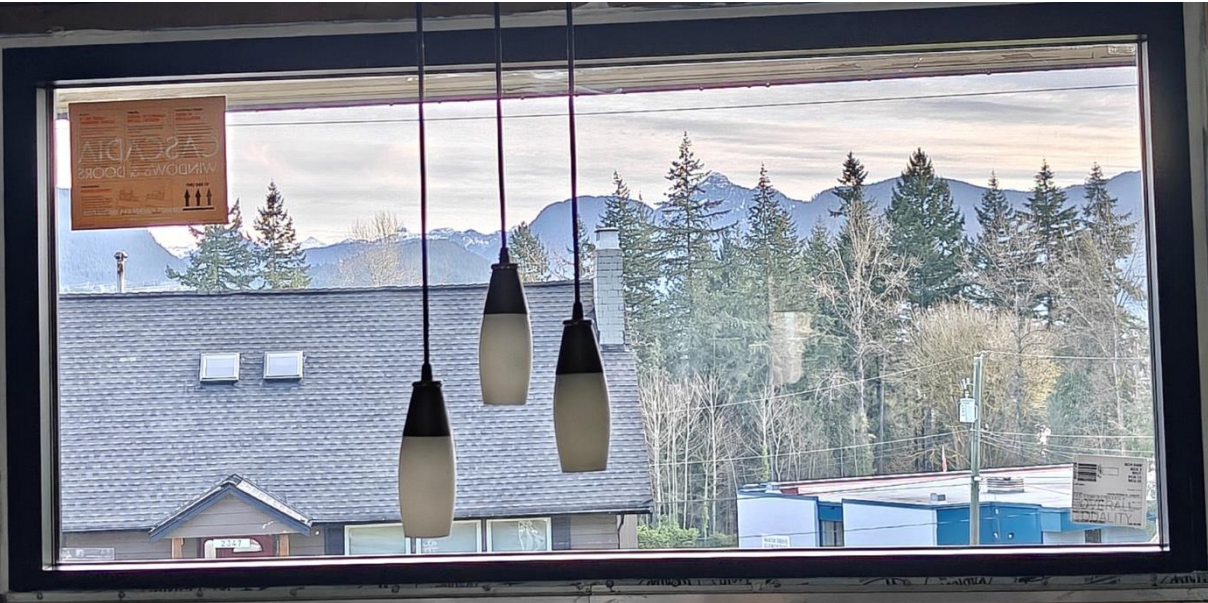
After – Triple Hybrid VIG out

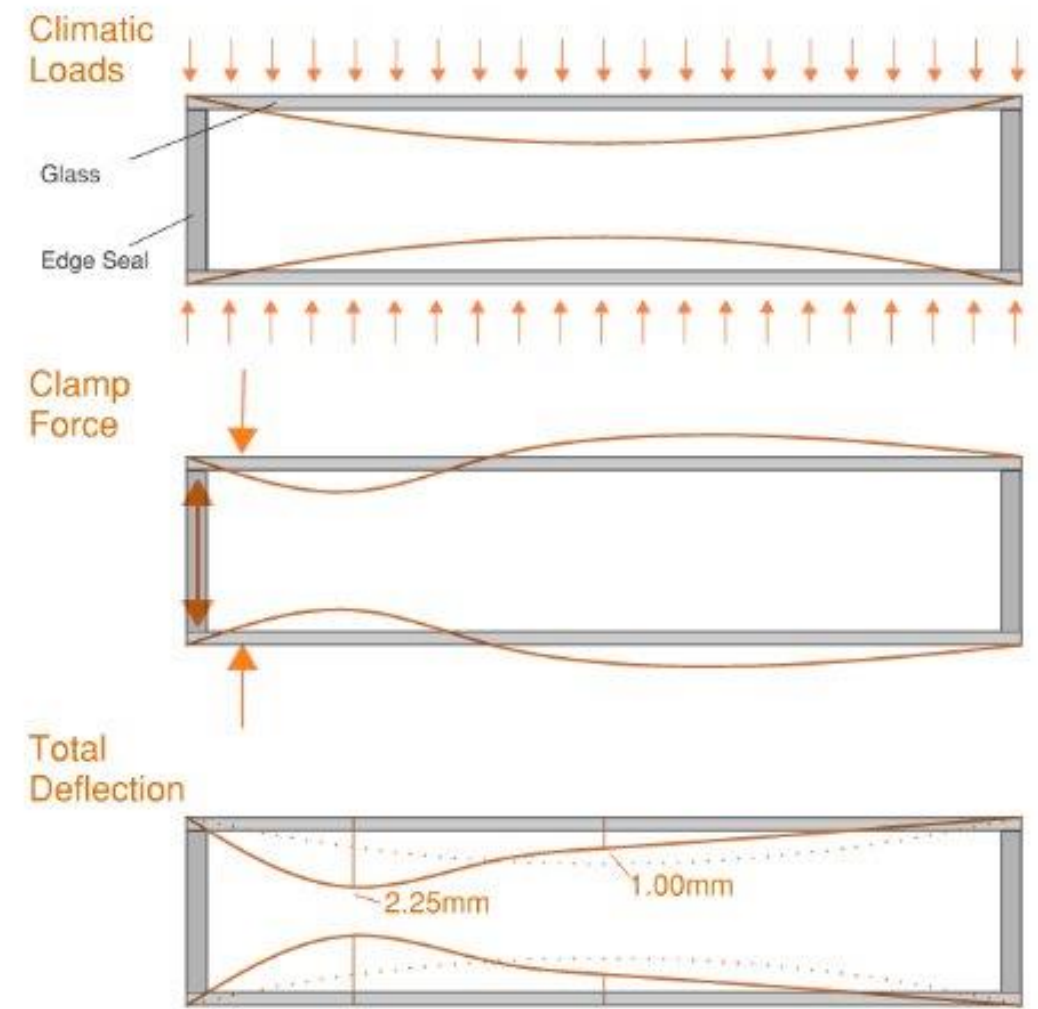
Table 3: Airspace Cavity Thickness Measurements with Glass-Chek ELITE 3200 - IGU Measured In-Situ Vertically Installed in Curtain Wall, dimension 65 7/16" x 90 11/16"

Distance (inches/mm) from left vertical mullion	3" (76mm)	12-16" (305-406mm)	32" (813mm)	63" (1600mm)
Location	Immediately adjacent to left vertical mullion	Location of optical distortion	Center of IGU	Immediately adjacent to right vertical mullion
Airspace thickness measured (mm)	12.6mm	9.5mm	11.8mm	14.2mm

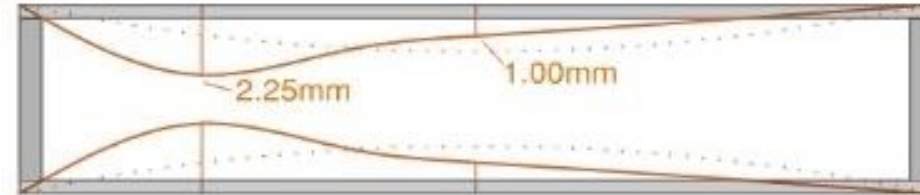
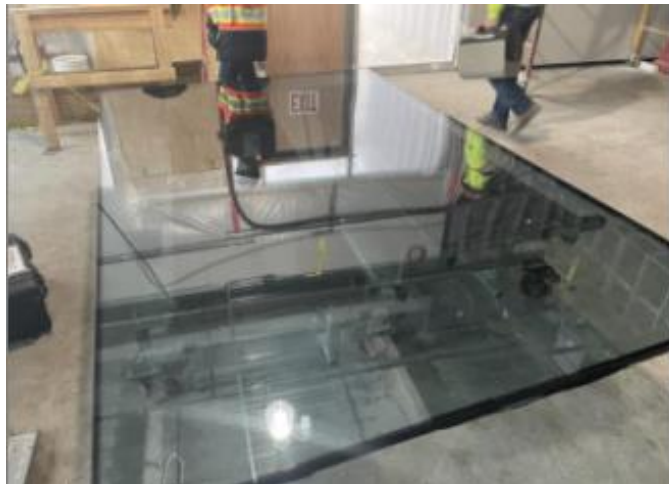
Total Deflection

Table 4: Airspace Cavity Thickness Measurements with Glass-Chek ELITE 3200 - IGU Measured horizontally after de-glaze, dimension 65 7/16" x 90 11/16"

Distance (inches) from left vertical mullion	3" (76mm)	12-16" (305-406mm)	32" (813mm)	63" (1600mm)
Location	Immediately adjacent to left vertical mullion	Location of optical distortion	Center of IGU	Immediately adjacent to right vertical mullion
Airspace thickness (mm)	13.4mm	11.1mm	14.2mm	14.2mm

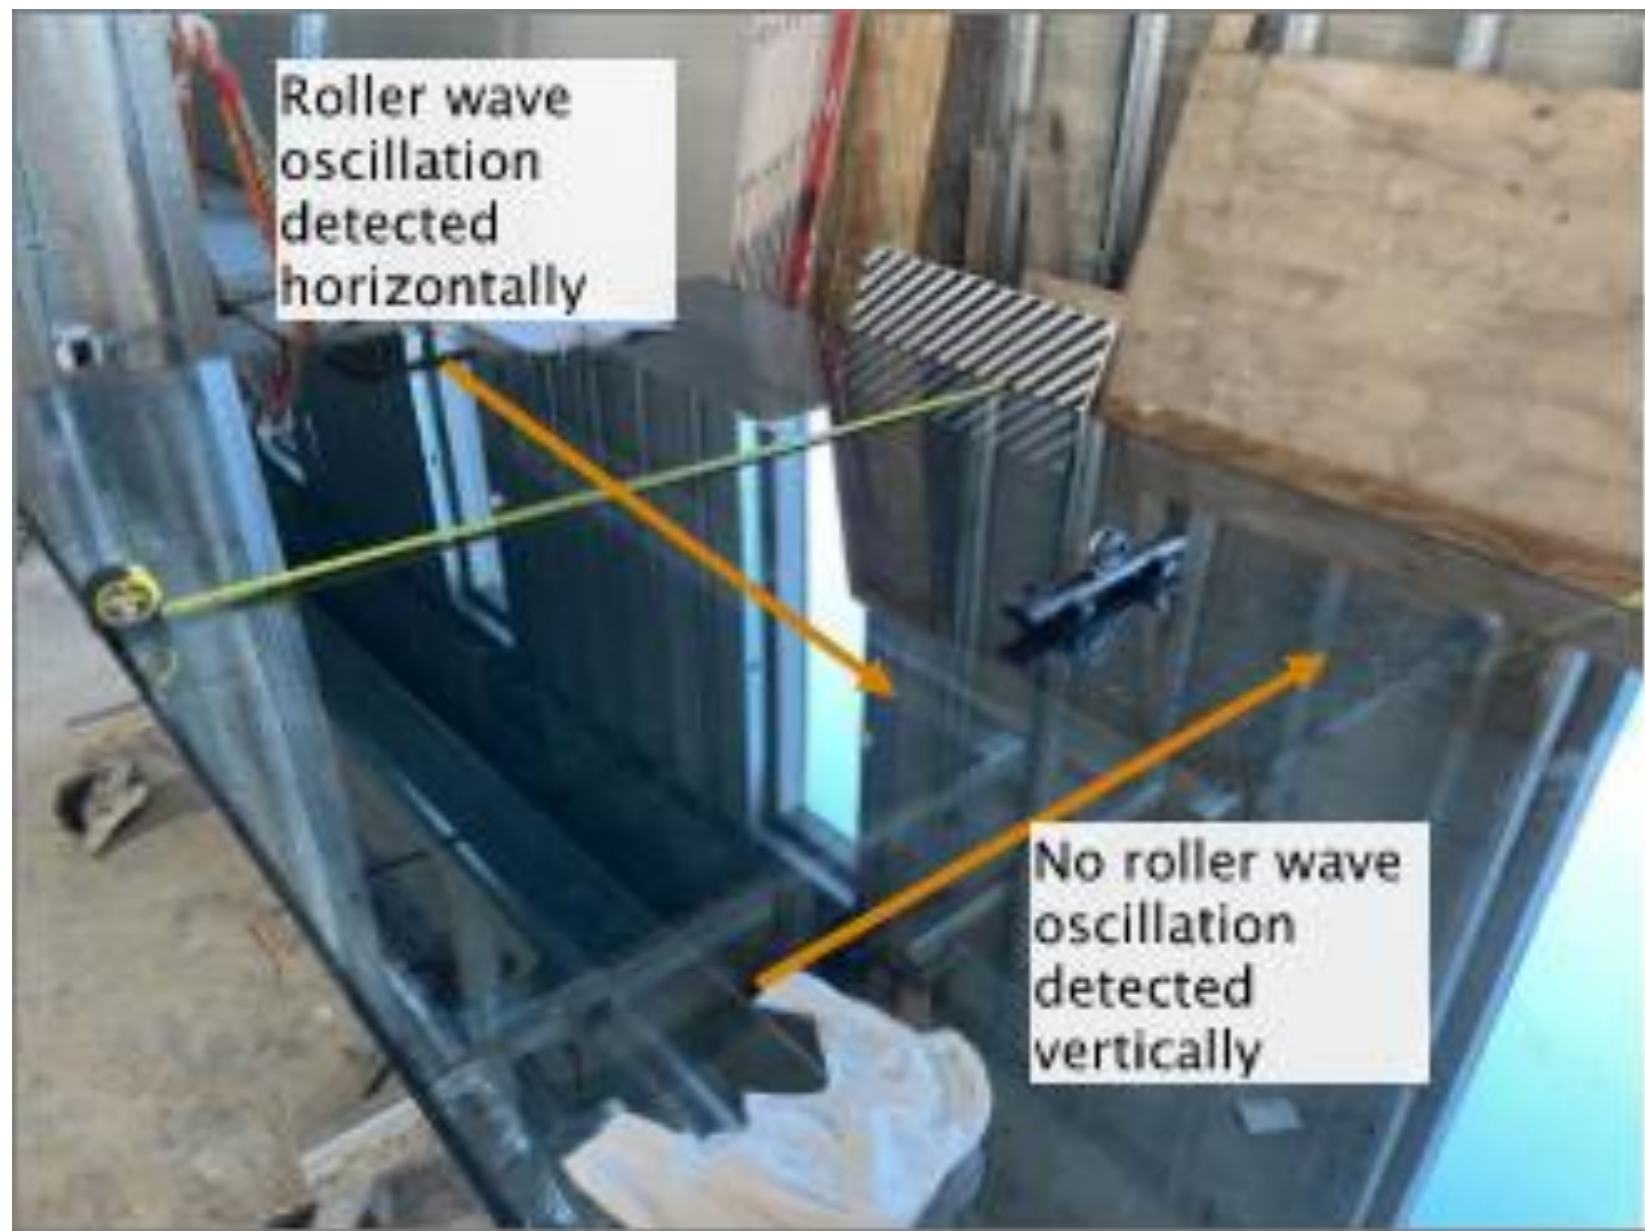
Roller wave
oscillation
detected
horizontally

No roller wave
oscillation
detected
vertically

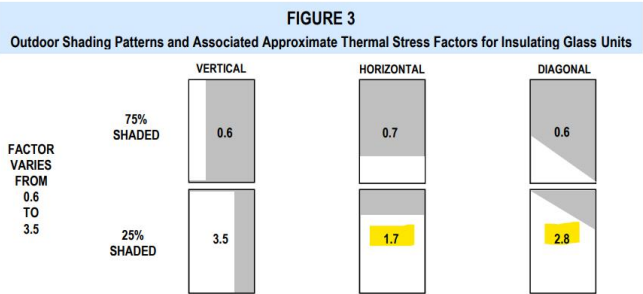
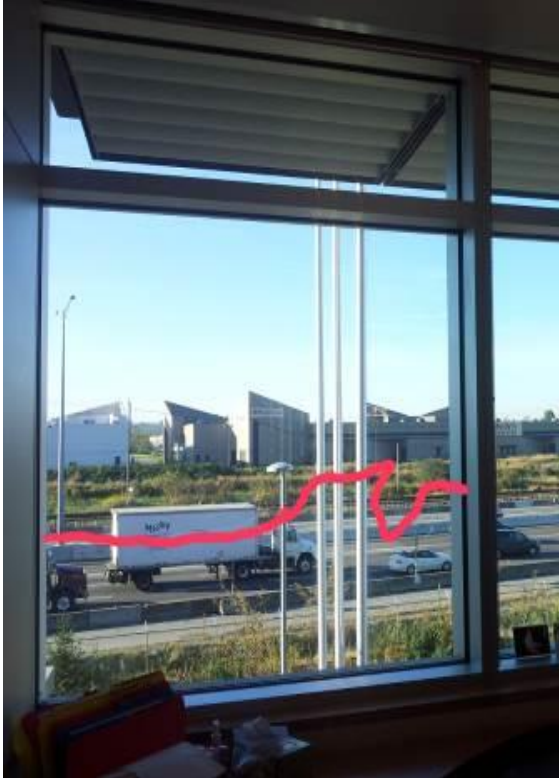
Thermal Stress Update

Case Study – Thermal Stress Breakage

- Breakage always occurred on sunny days on elevations with solar shades.
- Annealed glass was specified and installed.
- Breaks always intersect at 90 degrees to edge.
- Installation of glazing units conformed to IGMA guidelines.
- Conclusion: Thermal stress breakage
- A 28 Degree Celsius difference in glass temperature is often sufficient to cause breakage of annealed glass. Solar shading allows part of the glass to be exposed to the sun while shading other parts of the same lite causing a significant temperature difference. Reflective coatings and solar selective low-e coating compound this effect.
- **Heat strengthened glass should always be used on projects with solar shading devices or when using reflective or heat absorbing glass products.**

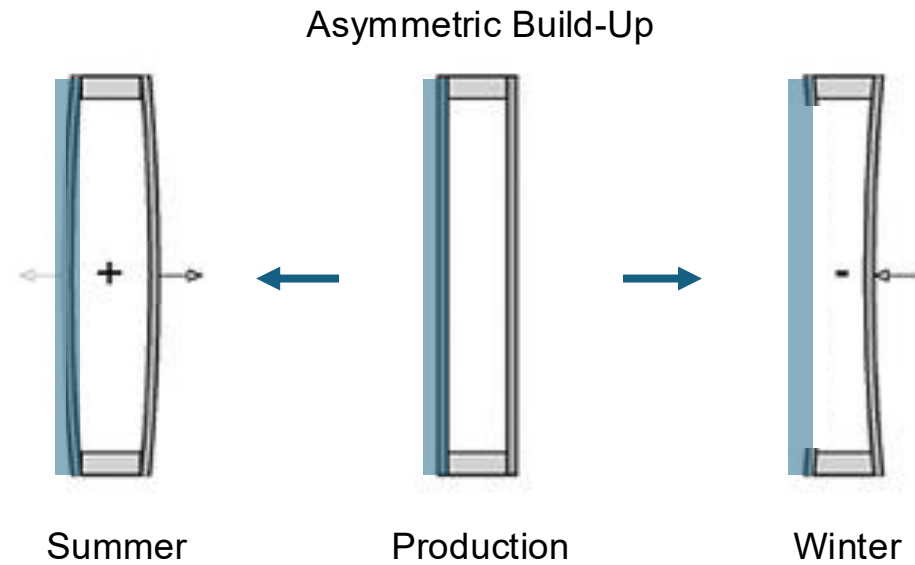
Climatic Load Deflection

Recommendations:

- Select a glass fabricator plant that is at a similar altitude as the site
- Engineer glass thickness in IGU assembly
- Some manufacturers offer pre-pressurization for final elevation
- Site crimped/sealed capillary tubes not recommended
